**Chapter 102 Inspection Report No. 26-02 —  
PAC210079A-4**

CUMBERLAND COUNTY  
CONSERVATION DISTRICT

Re: Pennsylvania Digital 1 (PAX-1)  
NPDES Permit Application No. PAC210079A-4  
Middlesex Township, Cumberland County

## CHAPTER 102 INSPECTION REPORT

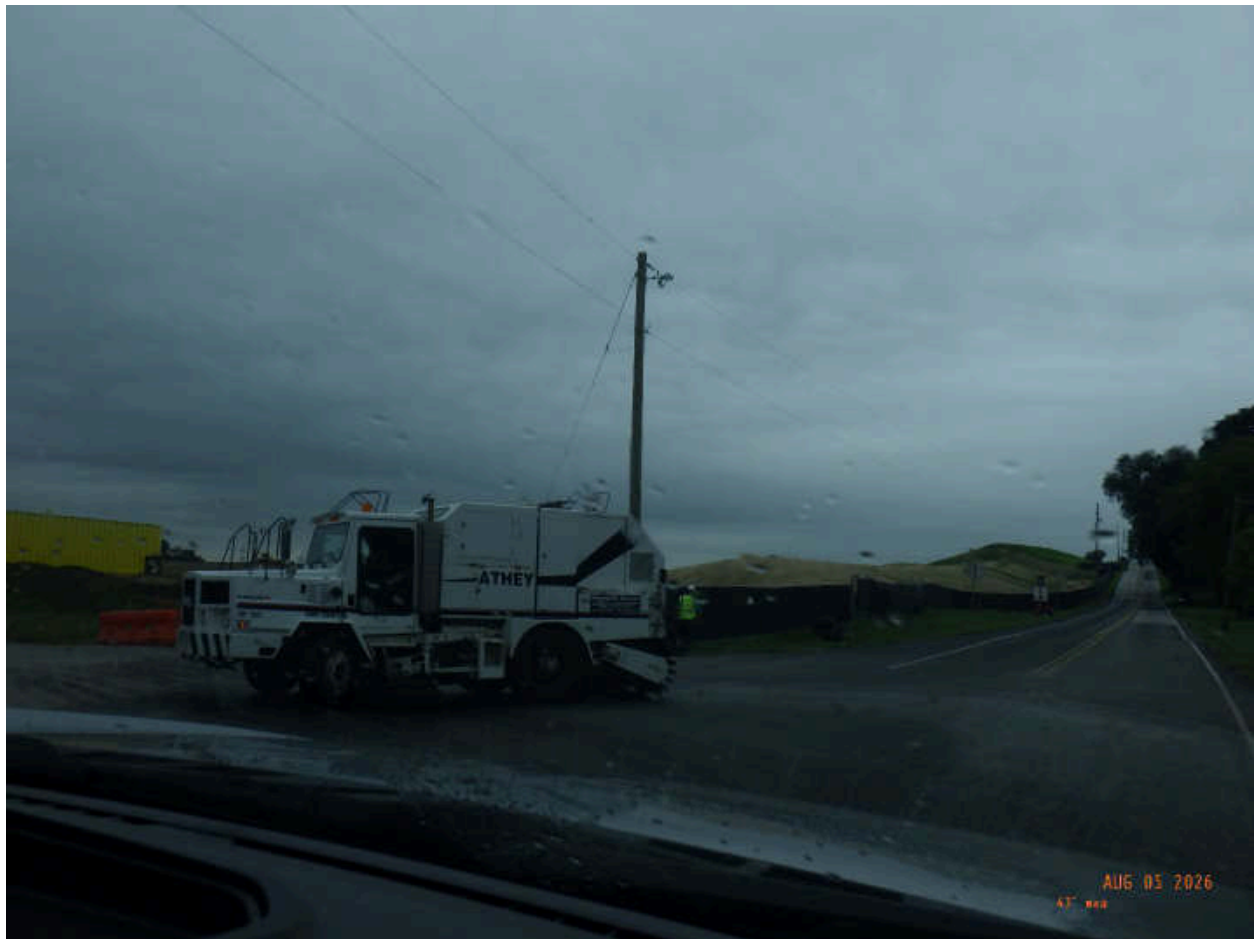
2. Active Street sweeping on Country Club Road was observed at the time of the inspection. Photo 1
  3. Existing PPL Laydown Sediment basin was full of stormwater but was actively being dewatered via trash pump and pumped water filter bag. The filter bag was situated on a well vegetated area and wrapped in a compost filter sock. Photos 2, 60-66.

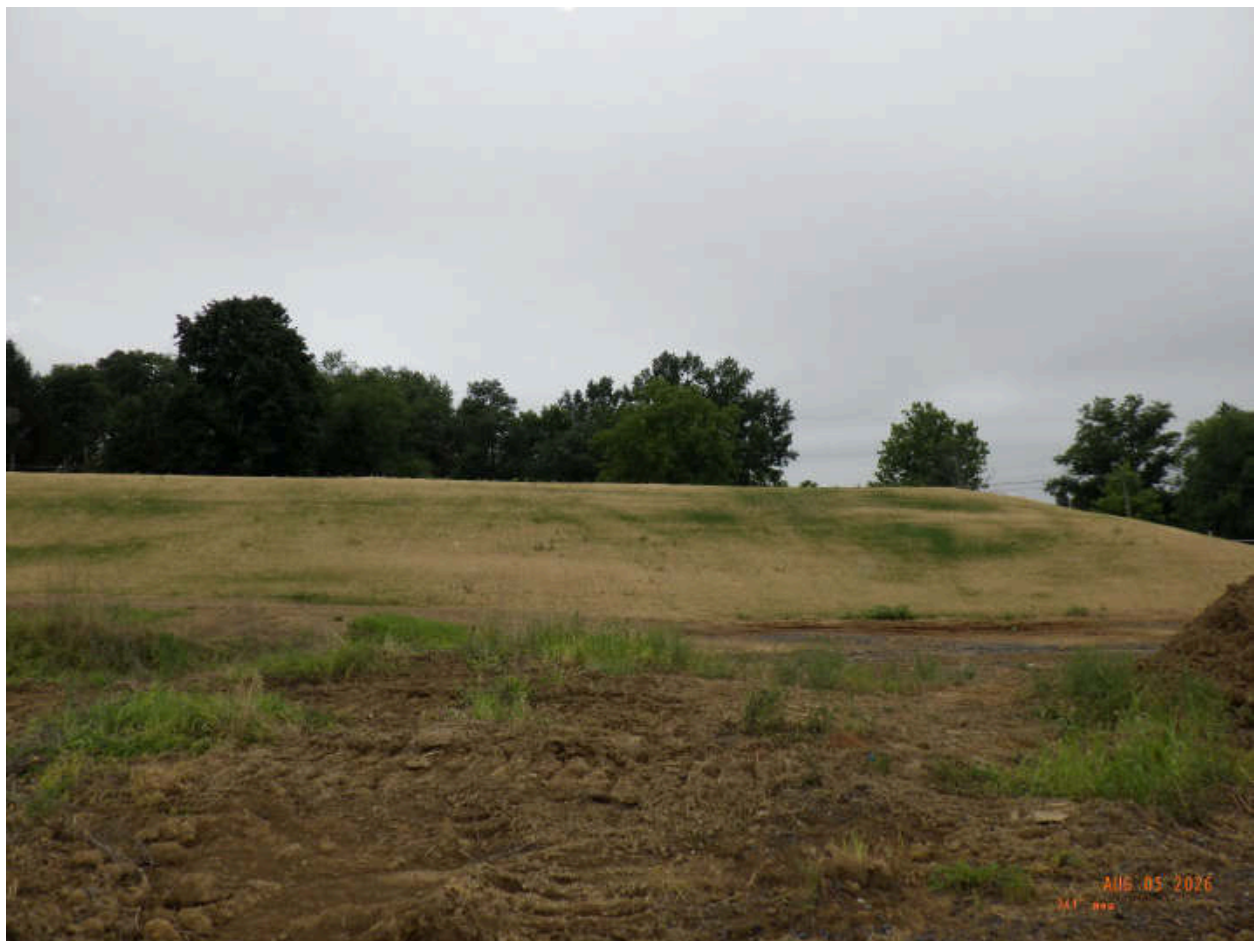
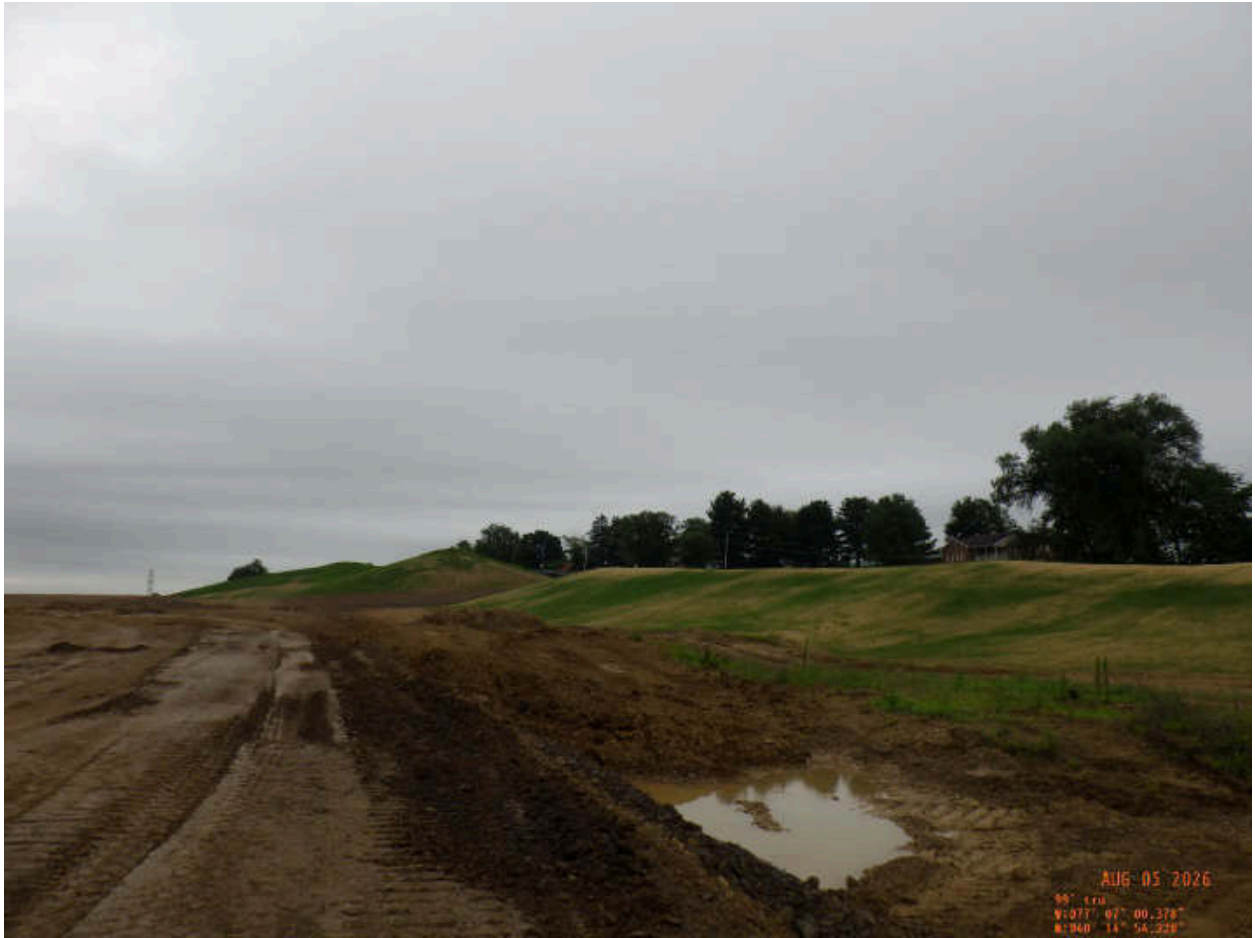
*Photo 4*

4. Topsoil screen berms appear to be complete and to final grade with vegetation establishing. Photos 4 & 5
  5. SCMs 4 and V5 (MRC) have been rough graded, with the current bottom elevation approx. 1' above proposed final elevation, it was noted that SCMs are required to dewater within 72 hours following each rain event. Photos 6-7

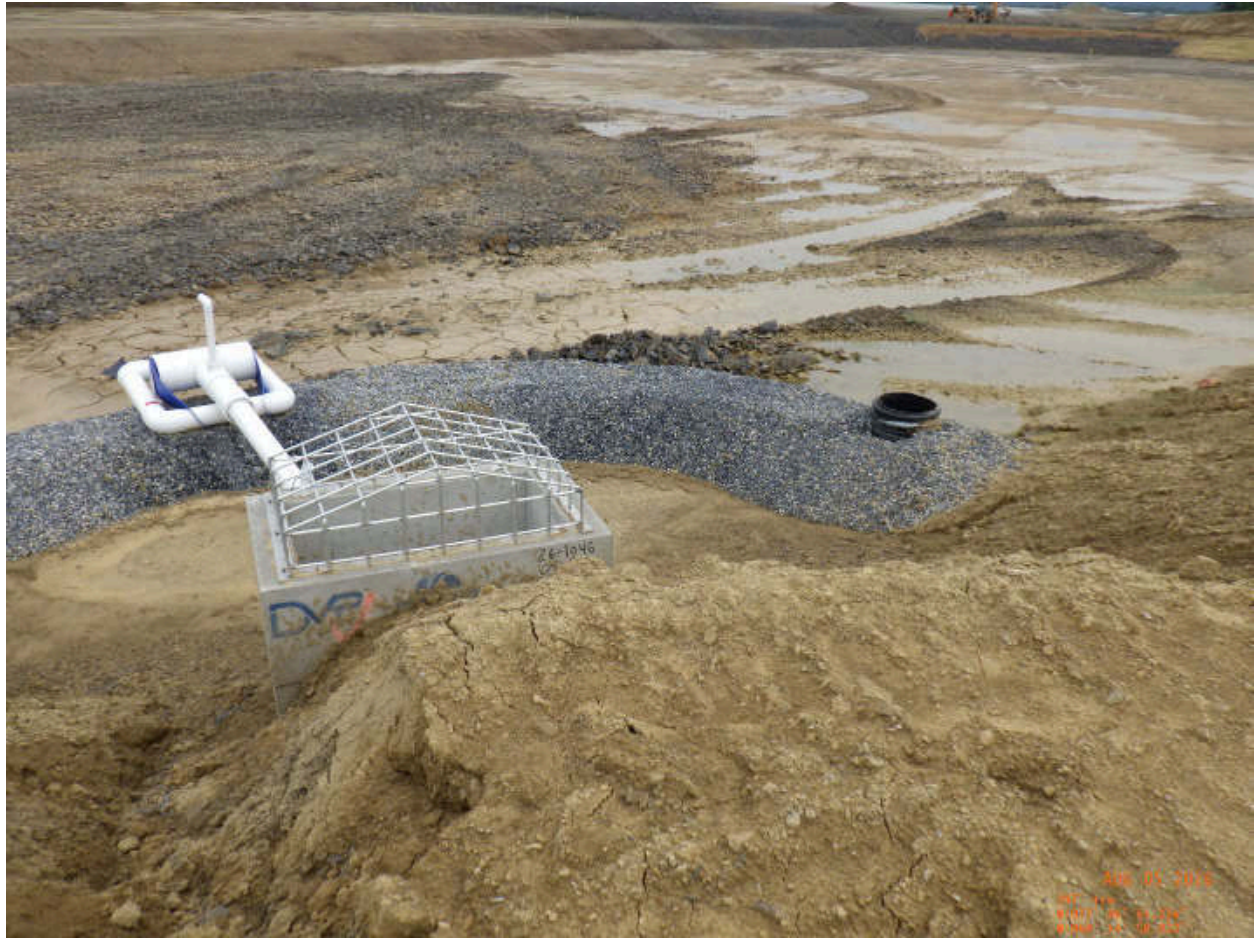
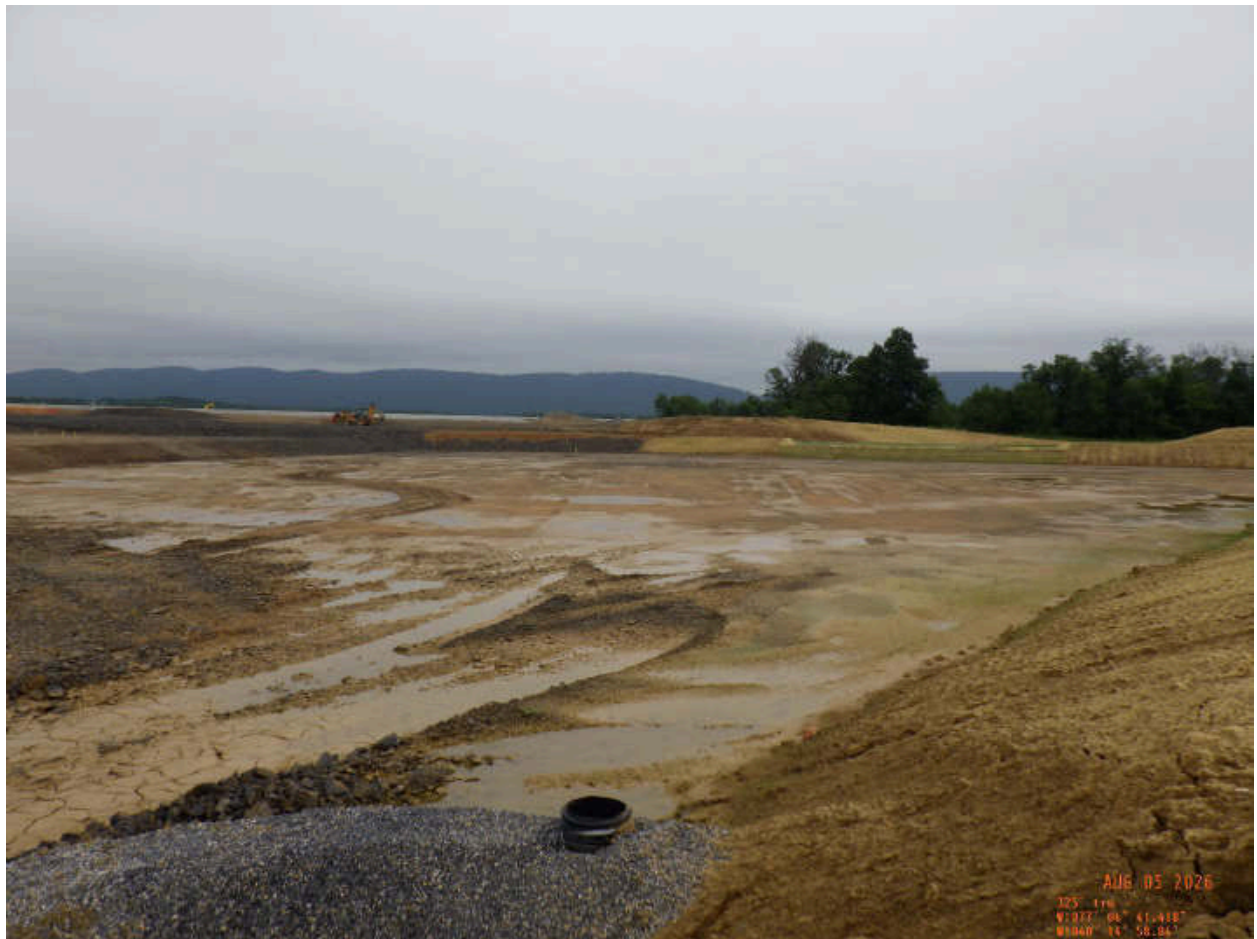
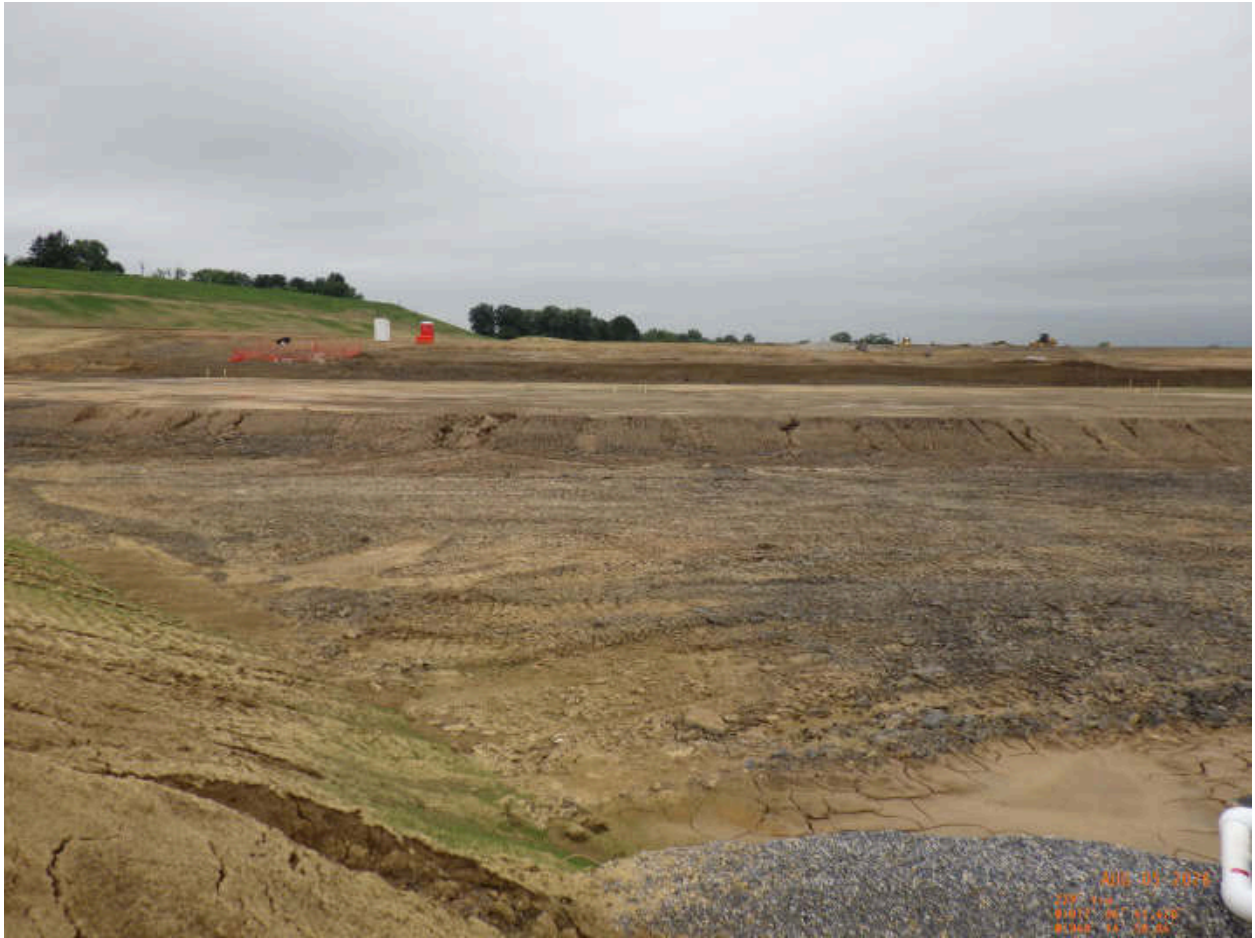
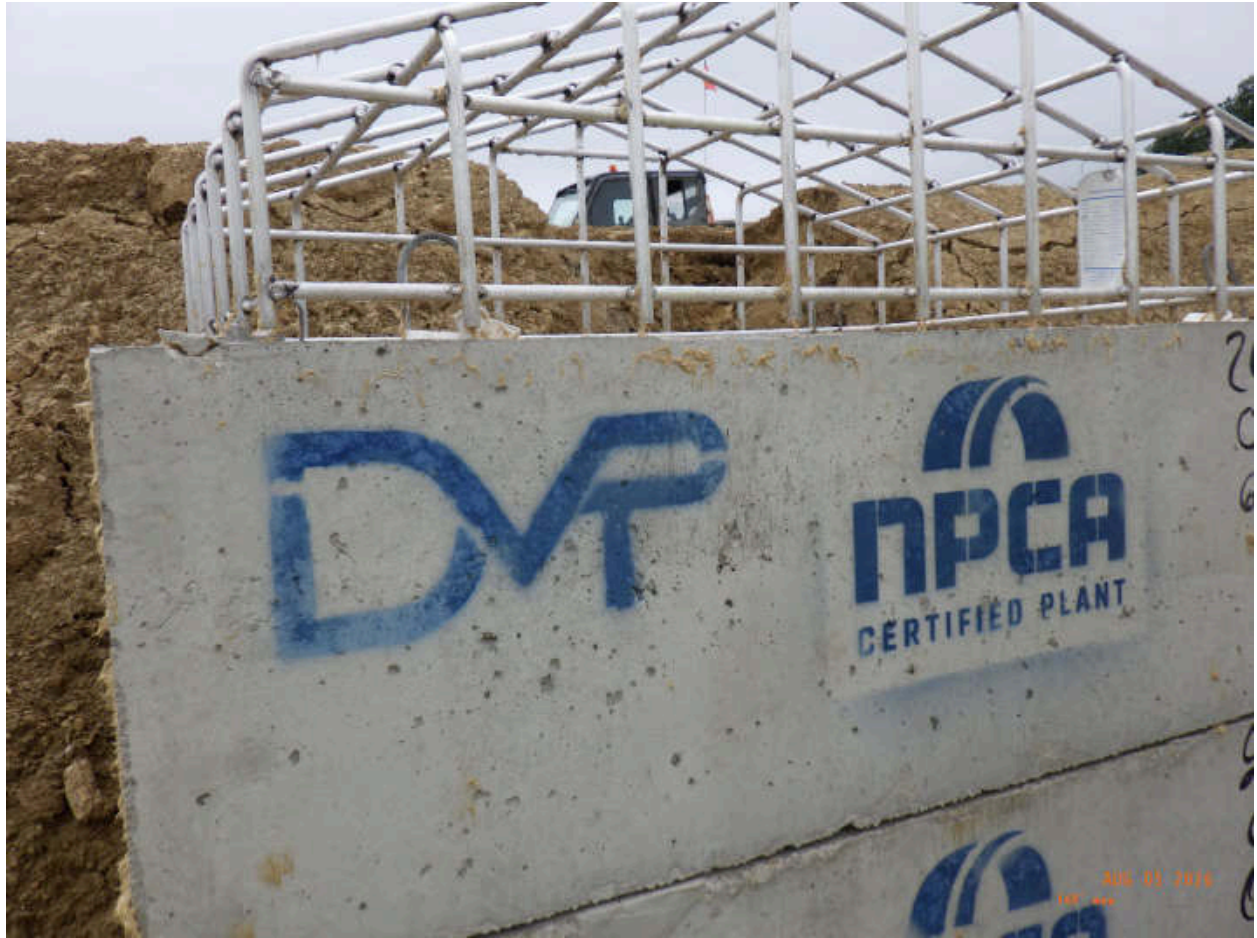
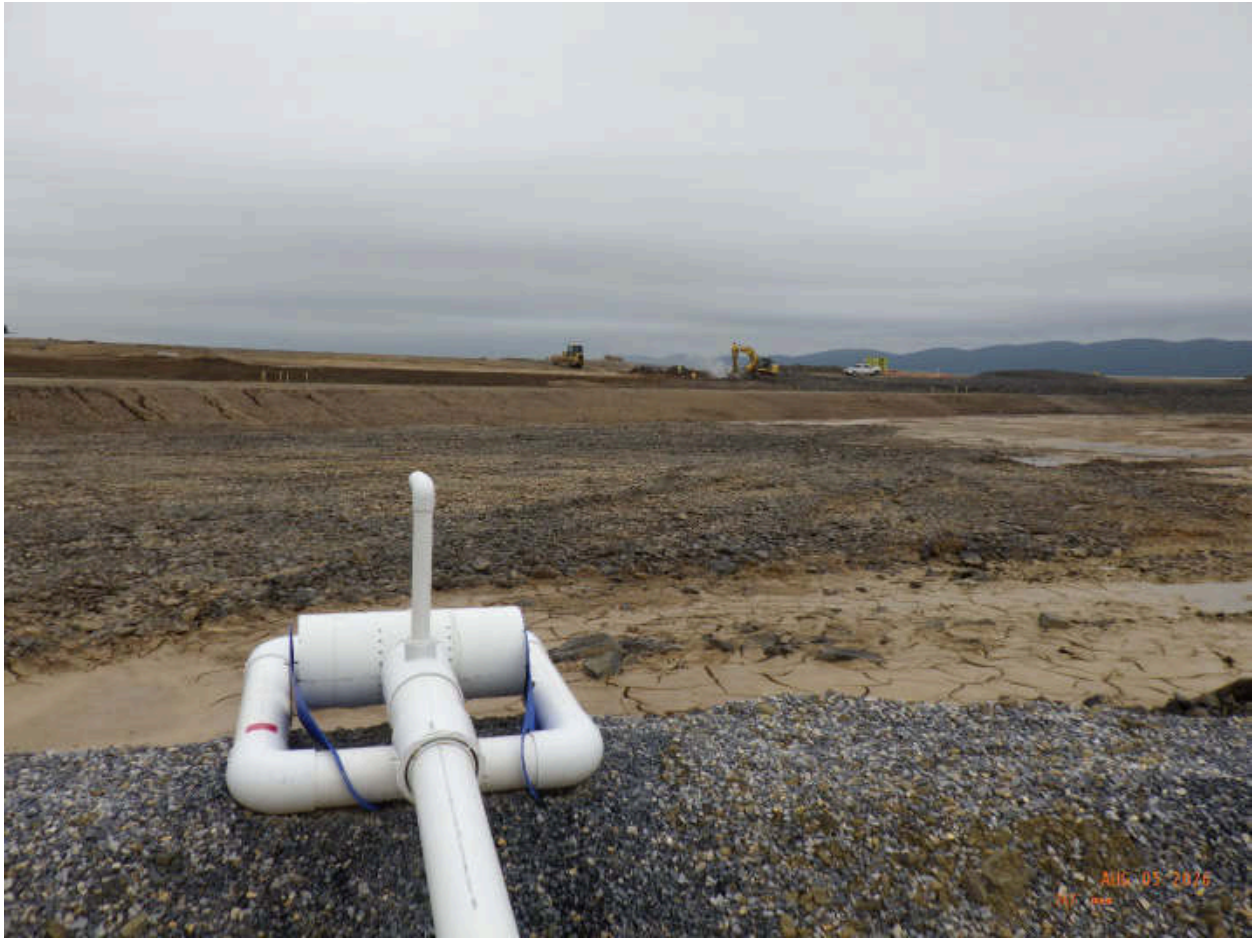
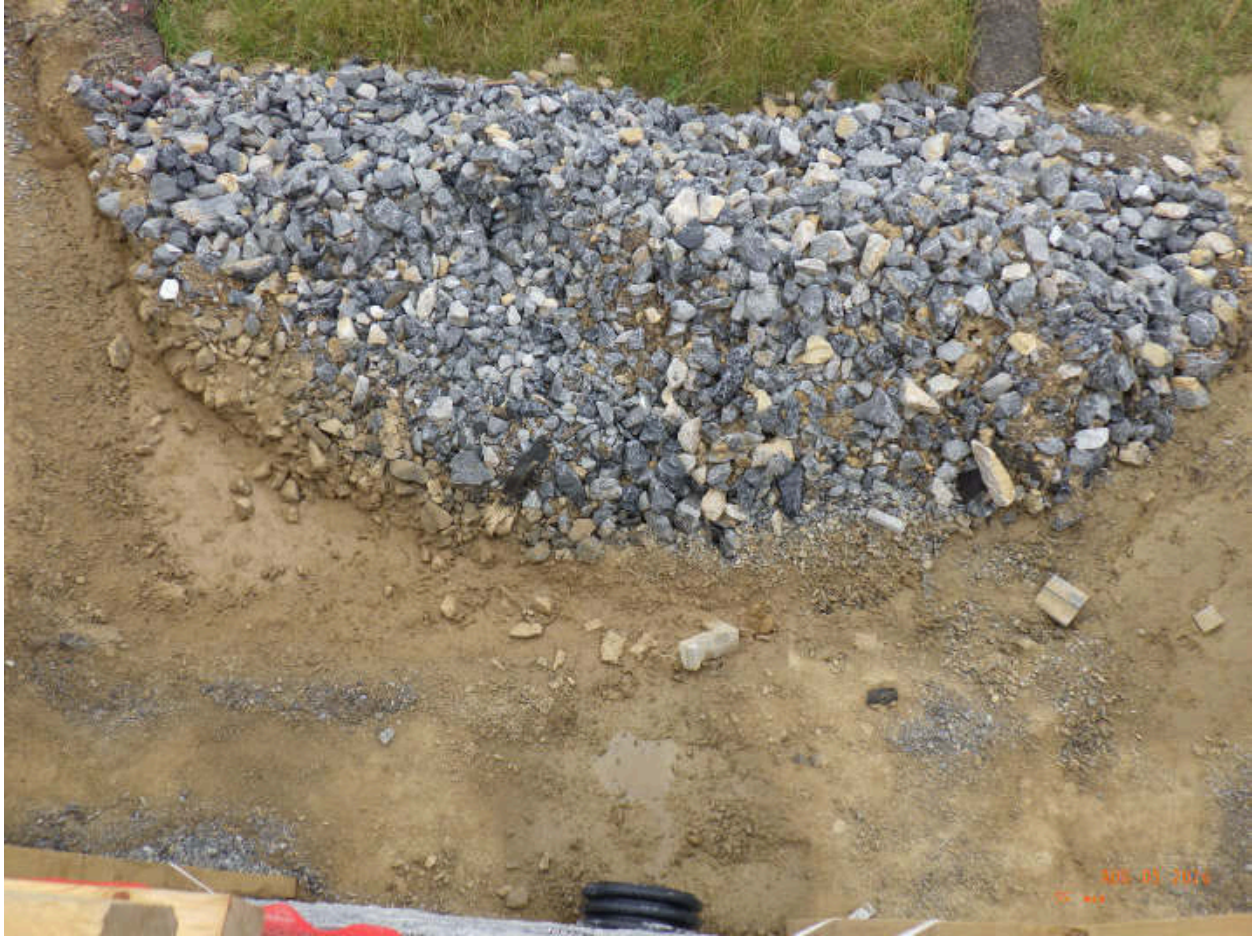
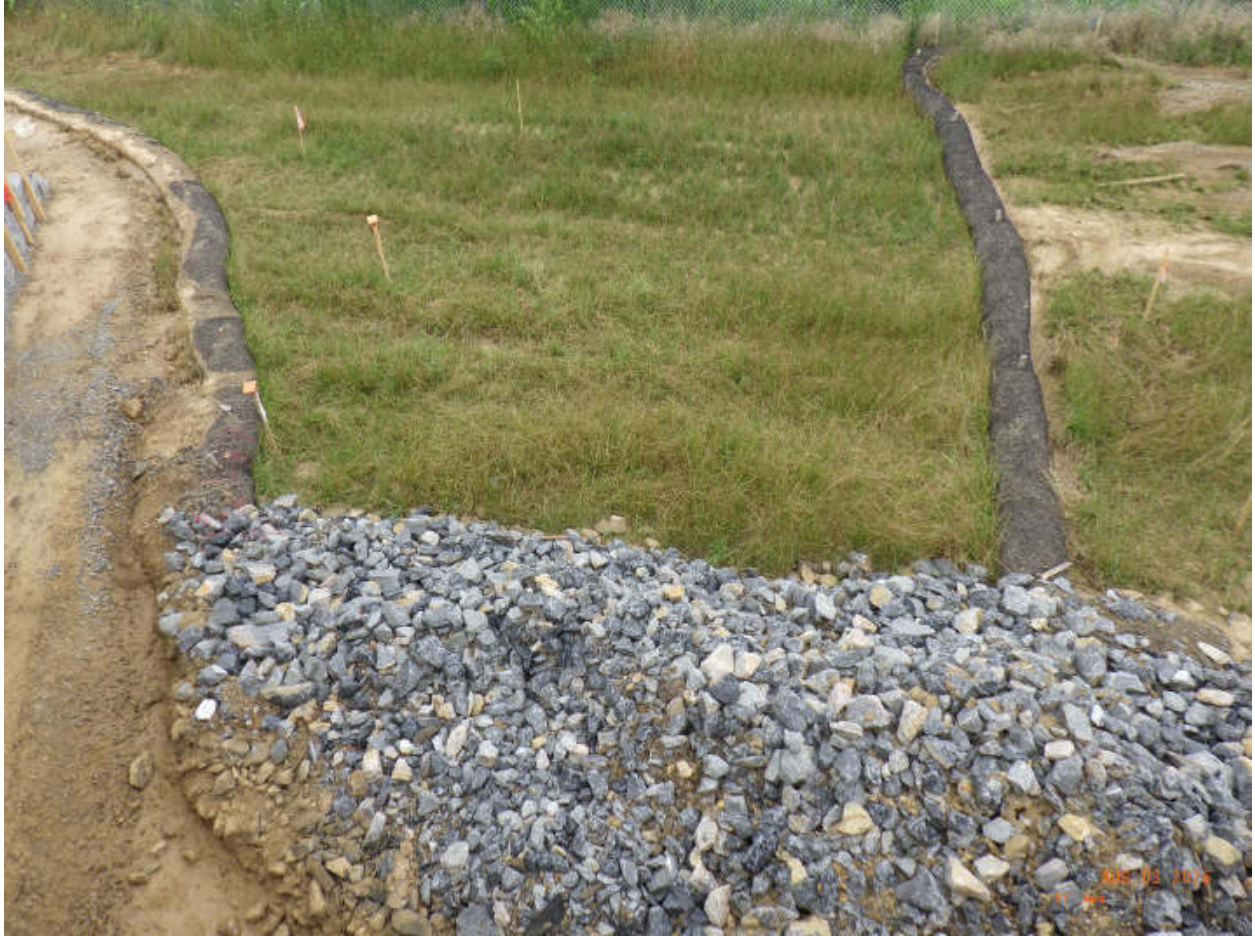
Photo 8

6. Sediment Basin A1 has been constructed with its outlet structure and skimmer. All seals appeared watertight based on visual observation. Plywood baffles and the sediment clean out stake were not observed to be installed at the time of inspection. Areas of erosion were visually observed at the basin's outlet; riprap had not yet been installed due to ongoing retaining wall construction in the vicinity. The potential use of R5 riprap was discussed on site with Liberty. Photos 8–14.

| <p>- CCCD recommends pumping the water from the Existing PPL Laydown Sediment Basin within 96 hours following a runoff event. This water may be utilized to spray the site to minimize dust. Sediment Basins are to be empty between runoff events. Using the system referenced in observation 3 of this report is ok.</p> <p>- Ensure the site continues to be inspected weekly and after each measurable runoff event (&gt;0.25 inches).</p> <p>- Ensure any area of the site that is idle for four (4) or more days, including stockpiles, is temporarily stabilized.</p> <p>- The observations noted within #6, 7, 8, 9, 10, 12, 13, 14 and 15 should be corrected as soon as possible. Once corrections have been made, the District requests Liberty to send photos of all repairs to the District.</p> | | |

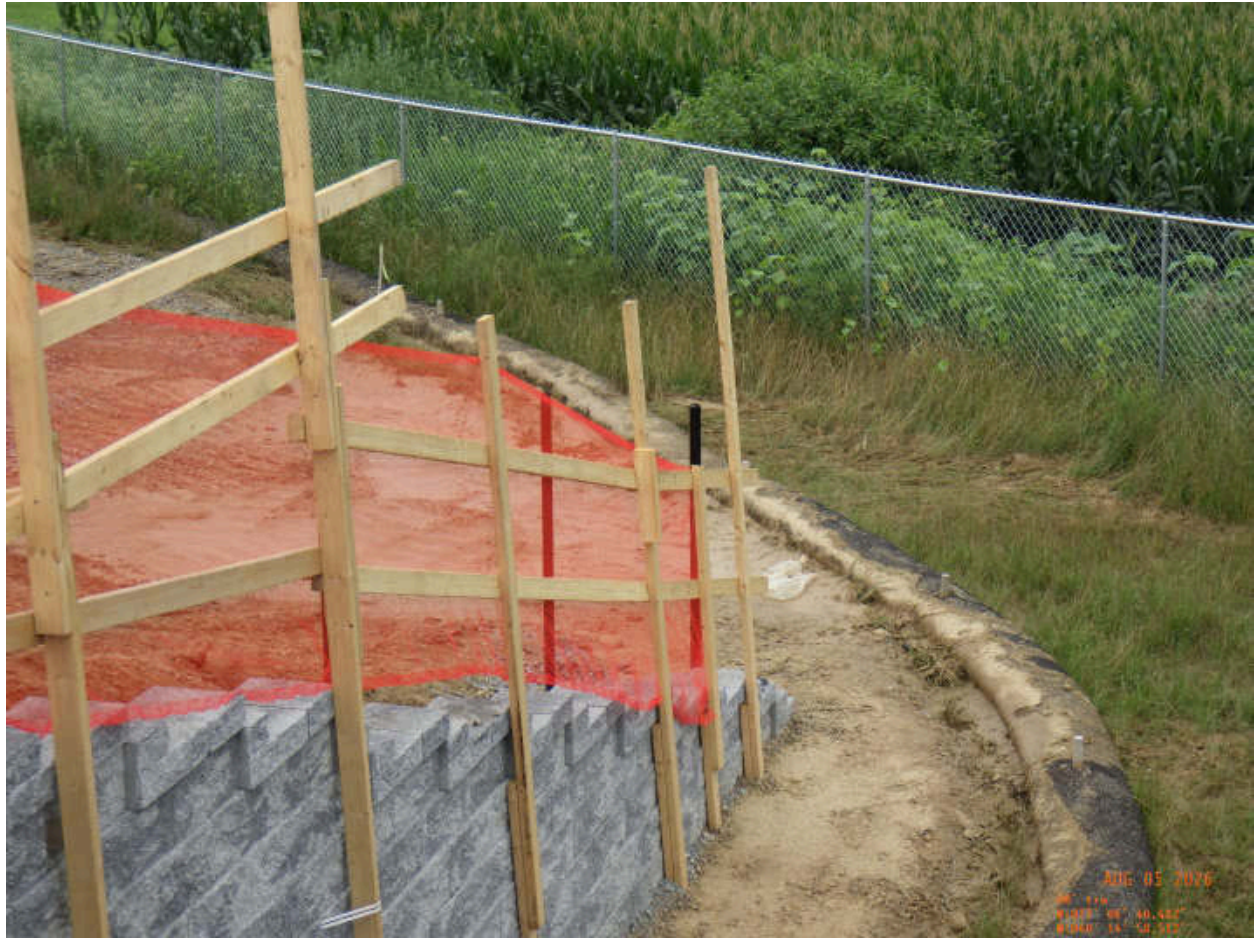
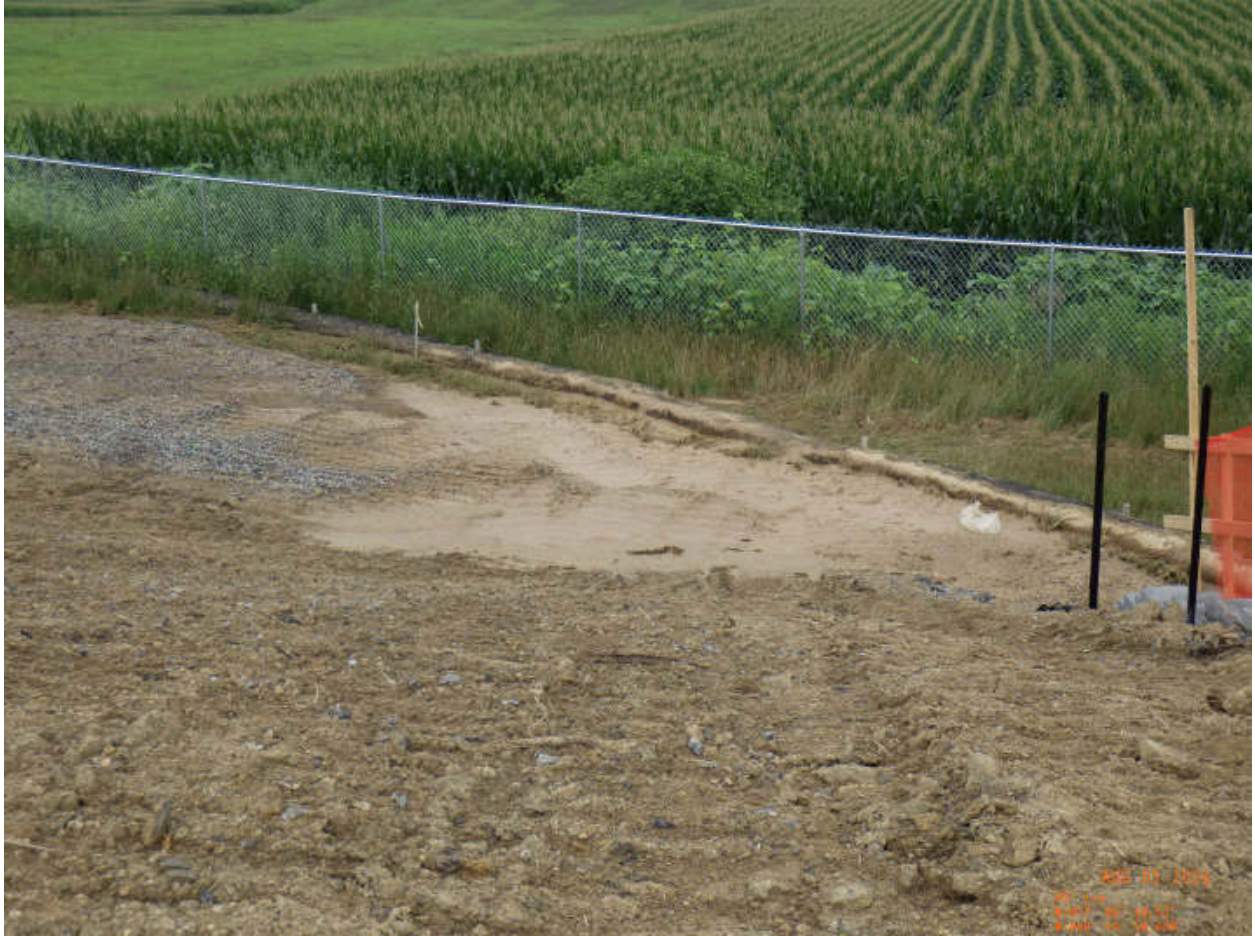
Photo 13

7. Compost Filter Sock (CFS) #4, located at the discharge of Sediment Basin A1, appeared to have overtopped during a recent storm event based on visible evidence. Photos 13–16.
