**Chapter 102 Inspection Report No. 26-02 —  
PAC210079A-4**

CUMBERLAND COUNTY  
CONSERVATION DISTRICT

Re: Pennsylvania Digital 1 (PAX-1)  
NPDES Permit Application No. PAC210079A-4  
Middlesex Township, Cumberland County

## CHAPTER 102 INSPECTION REPORT

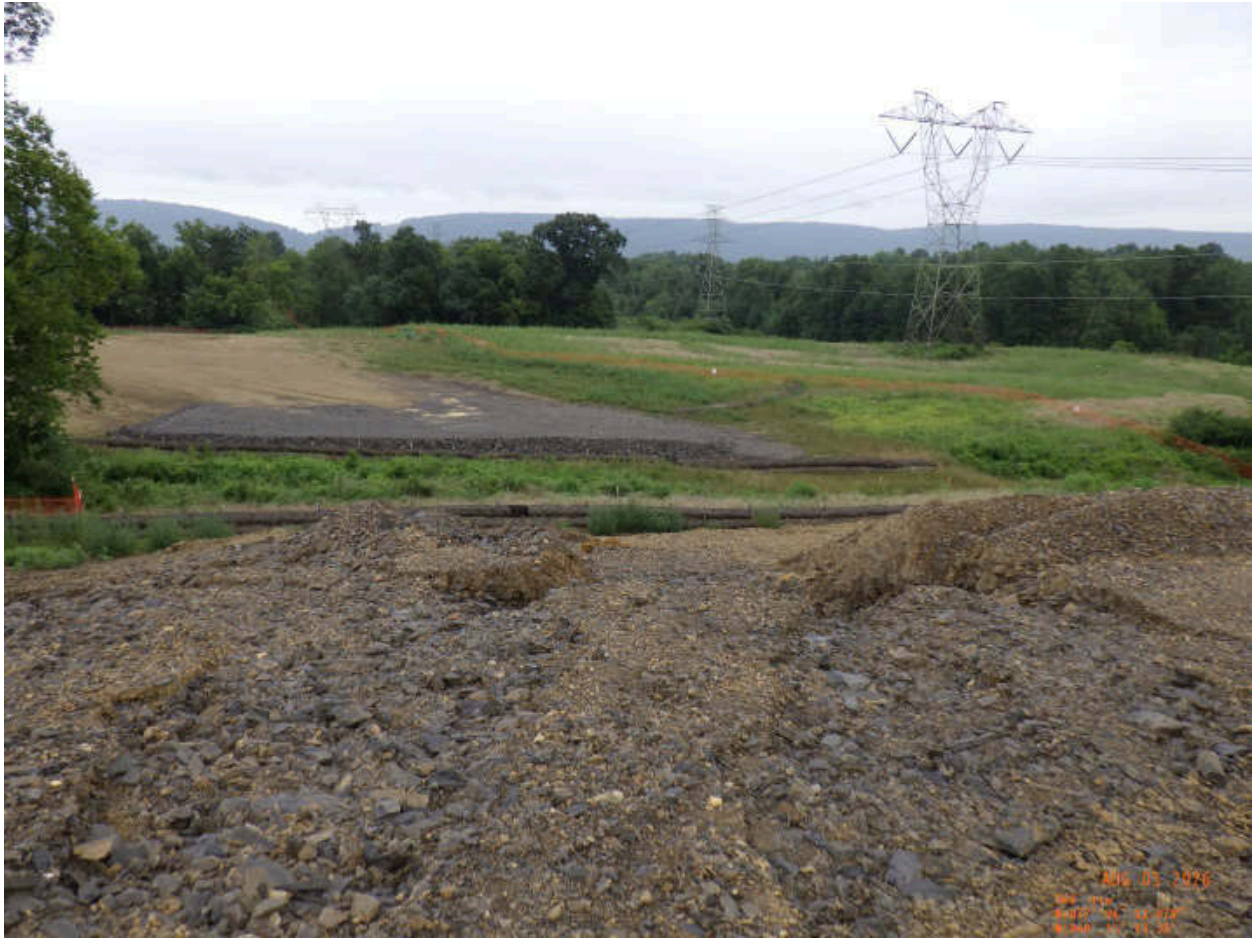
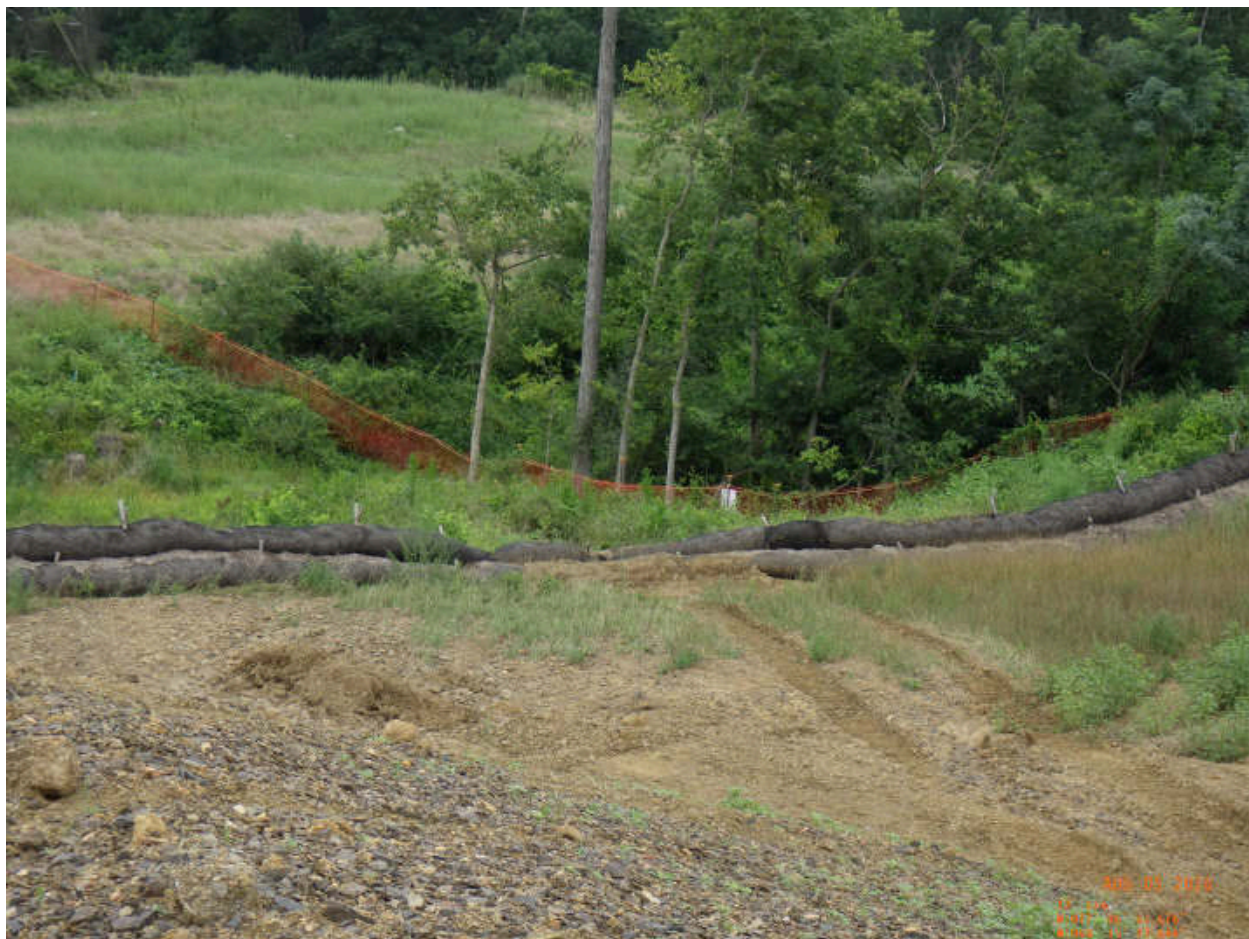
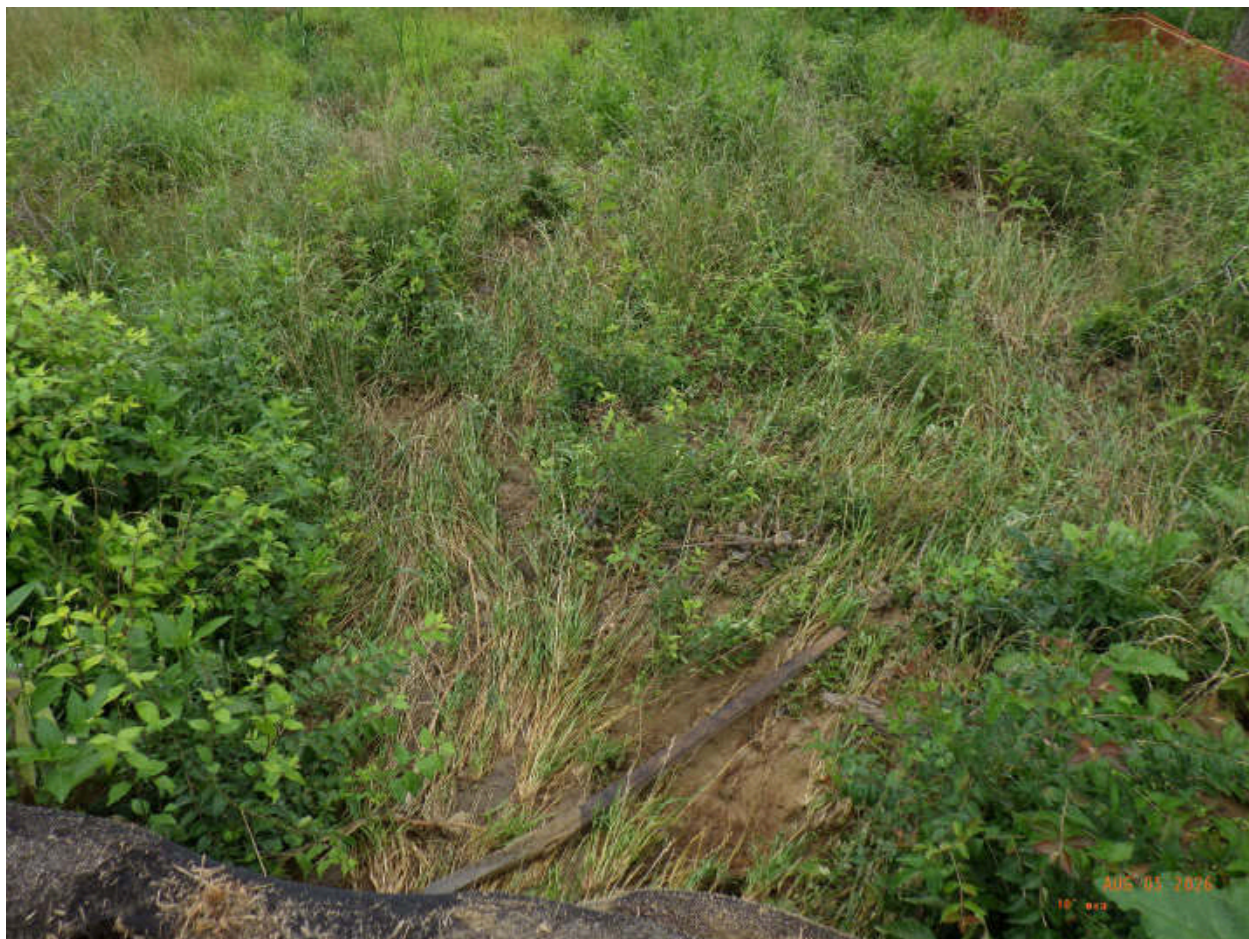
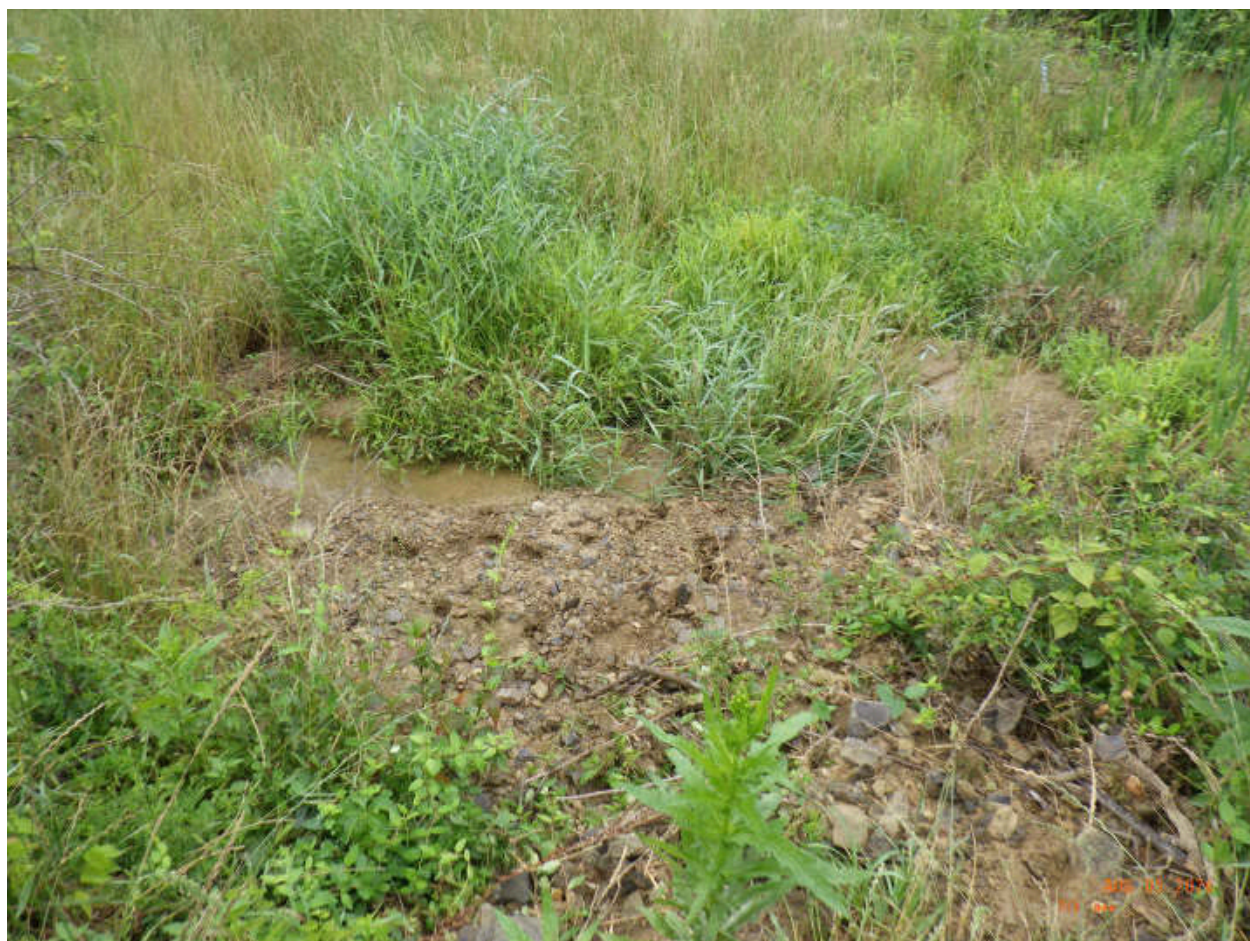
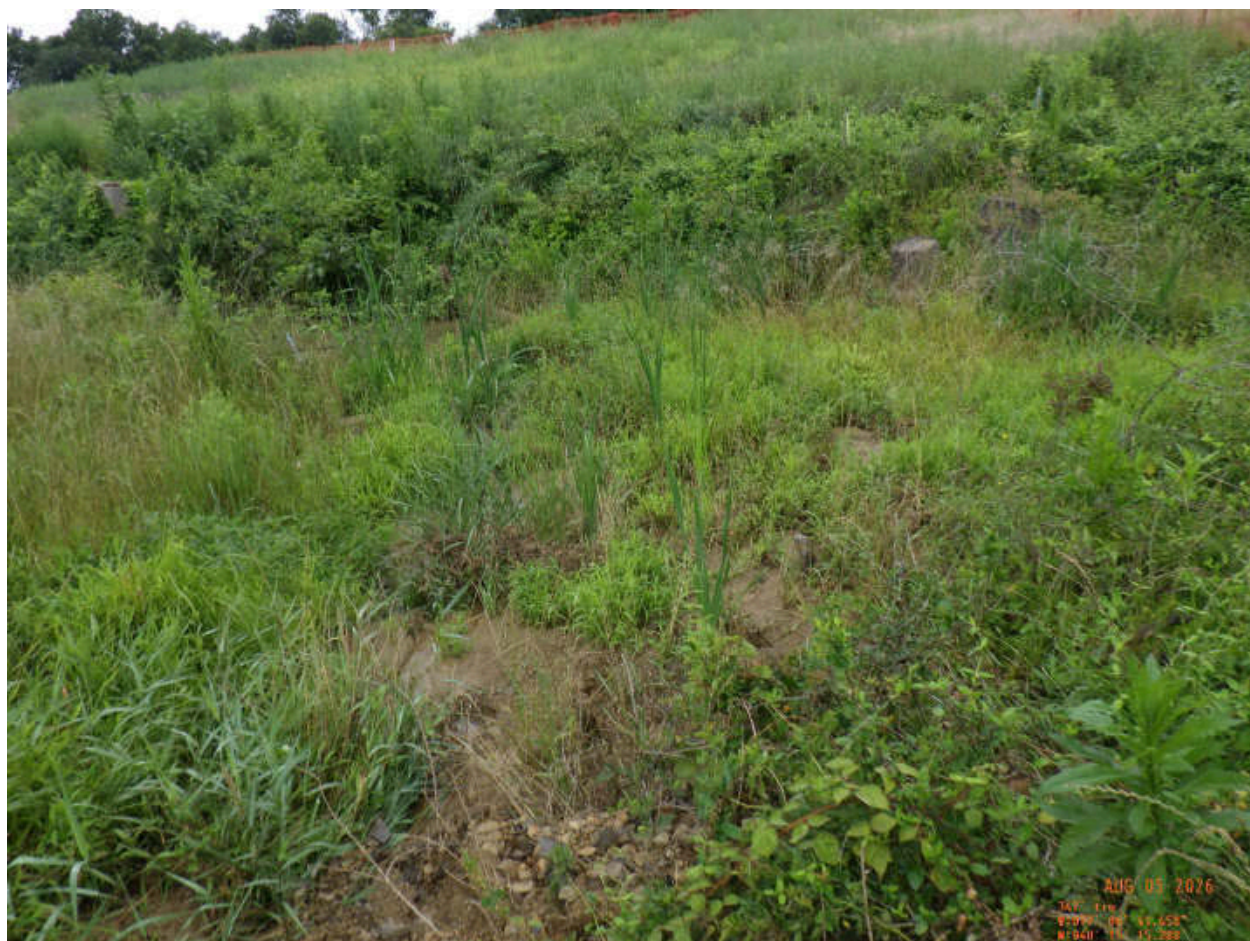
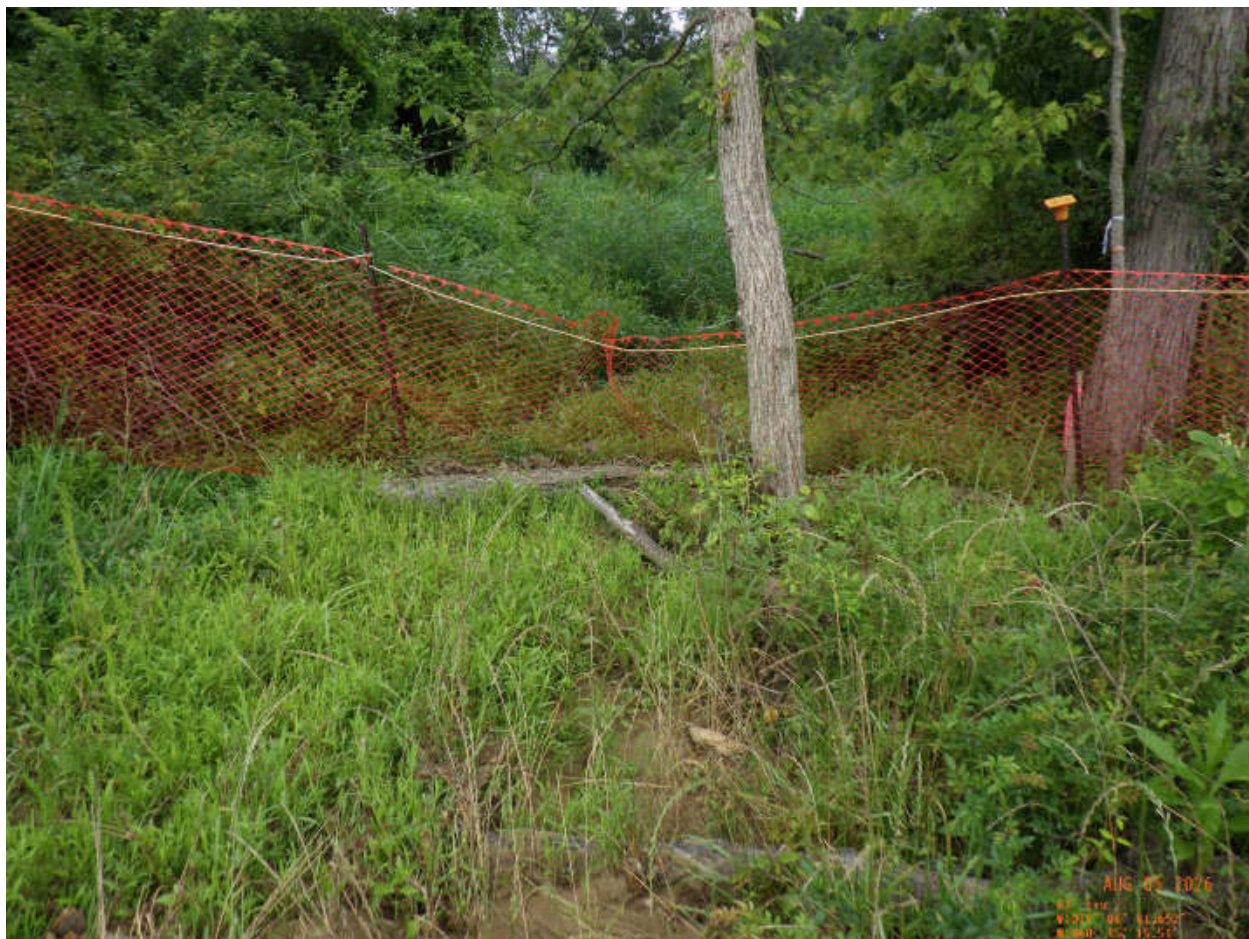
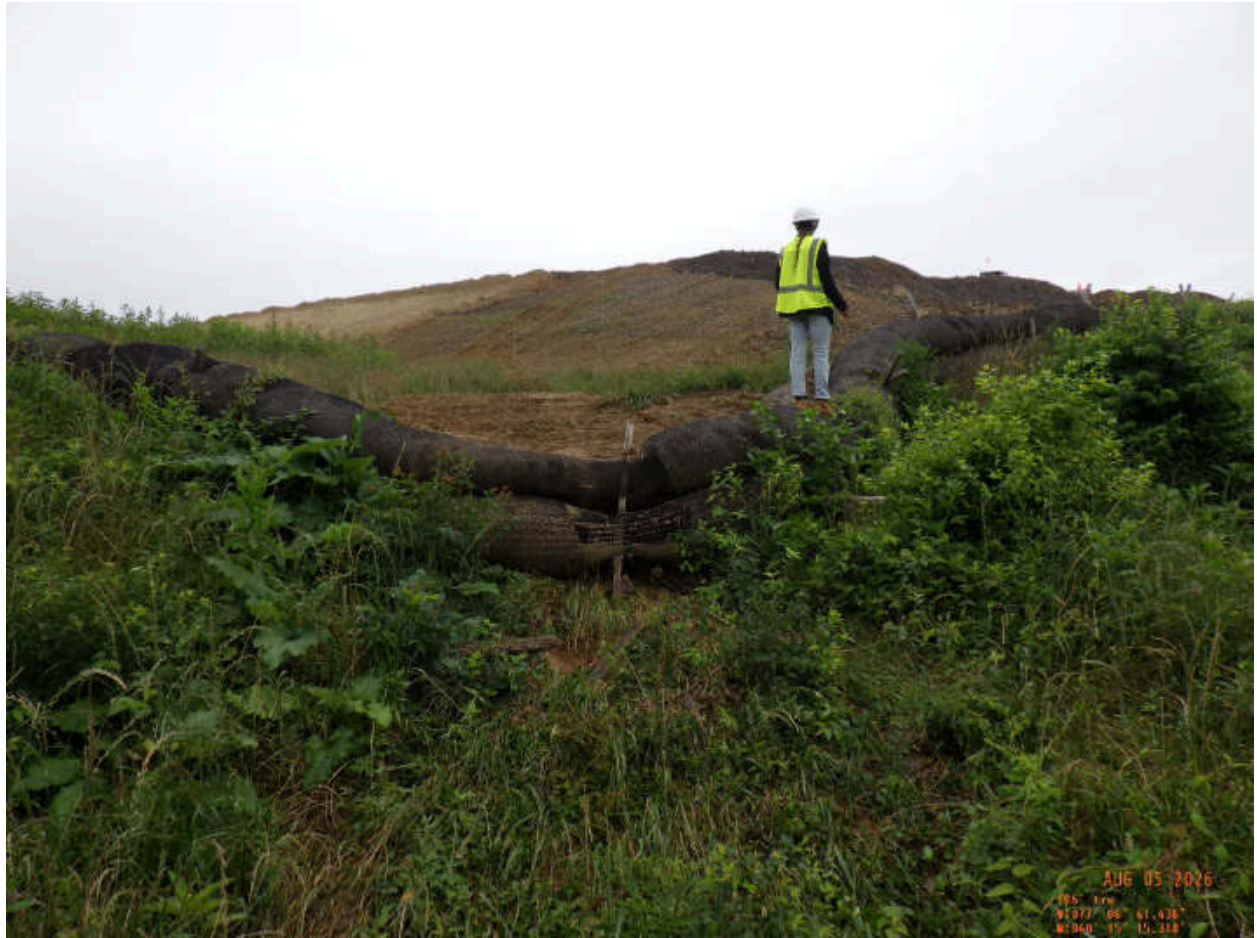
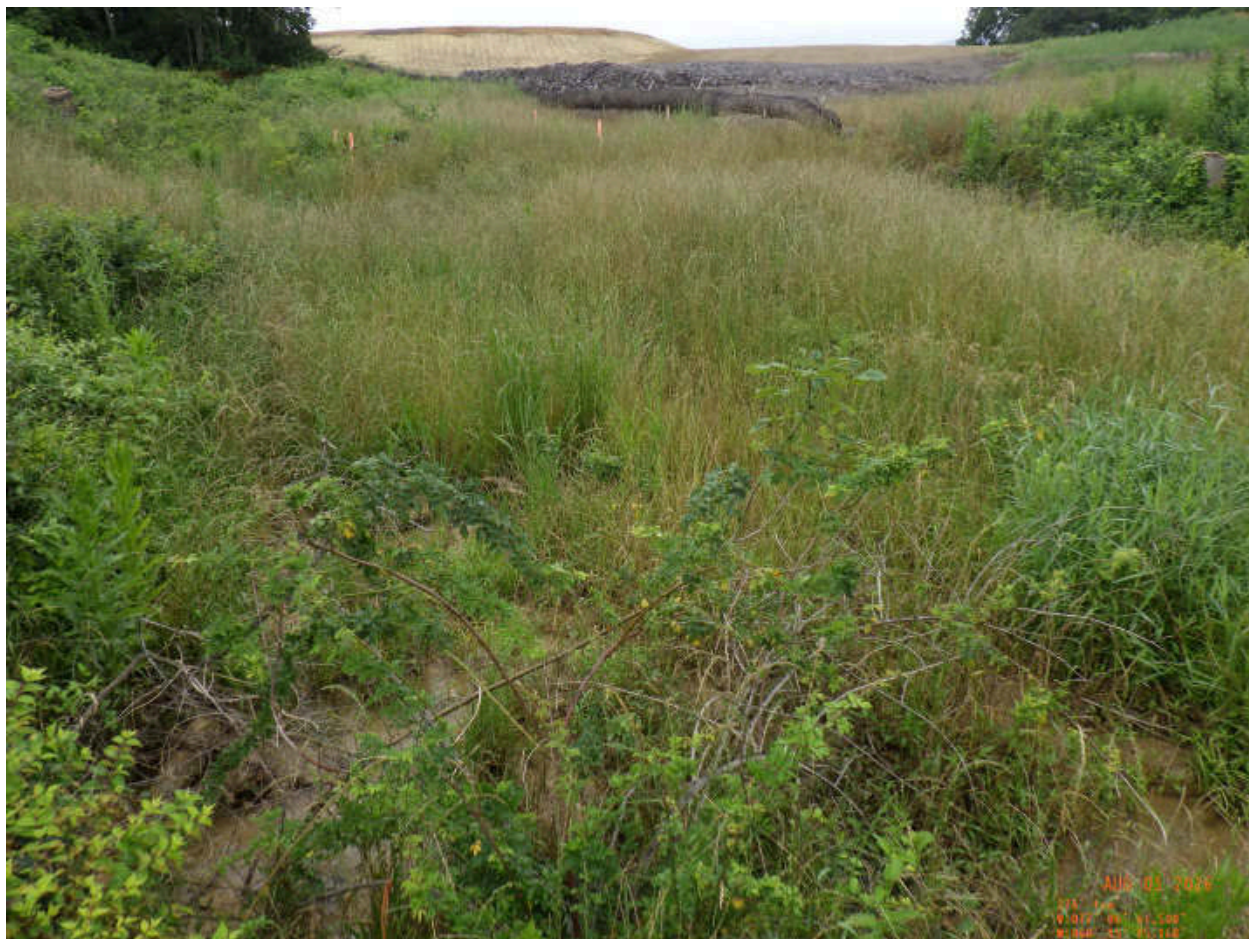
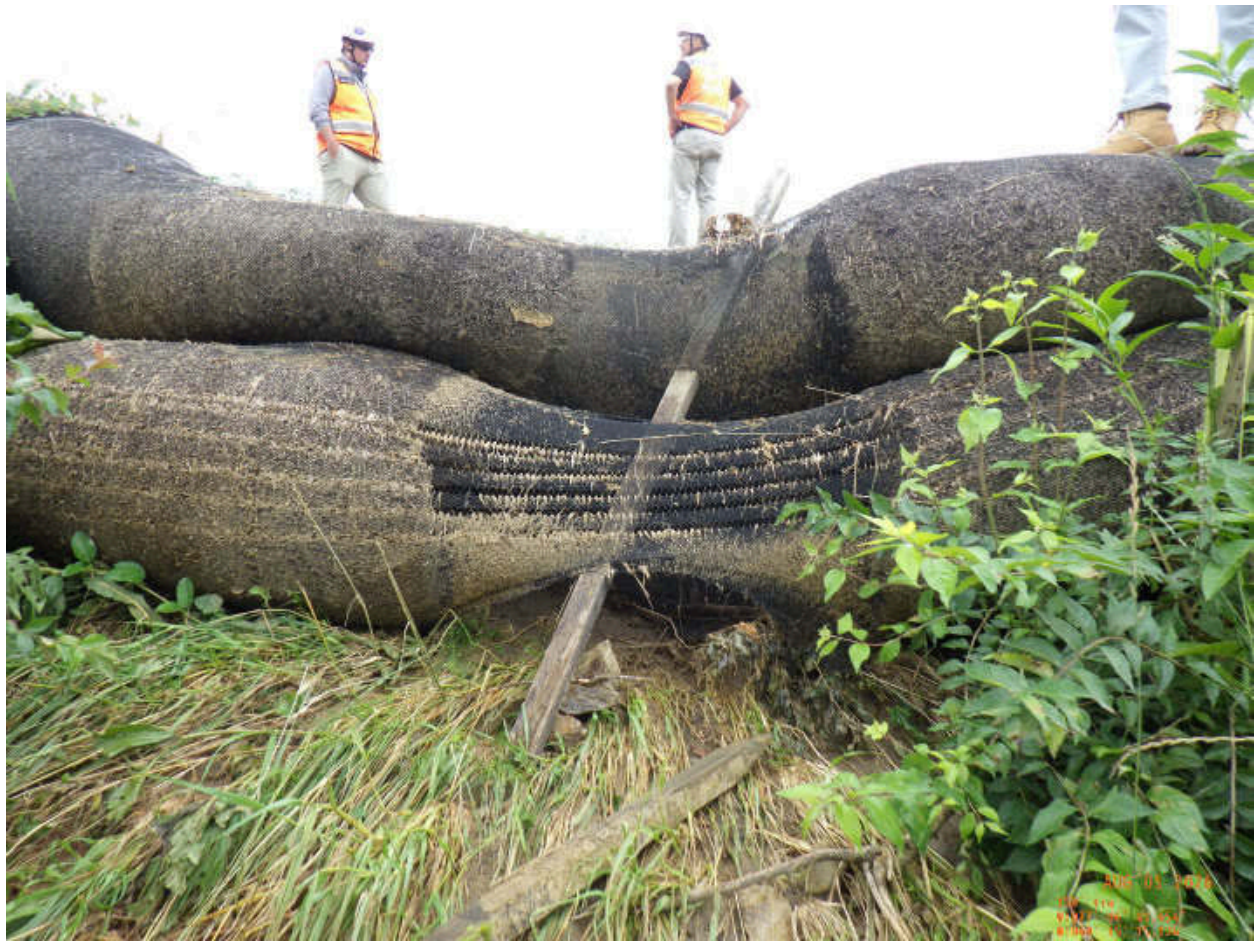
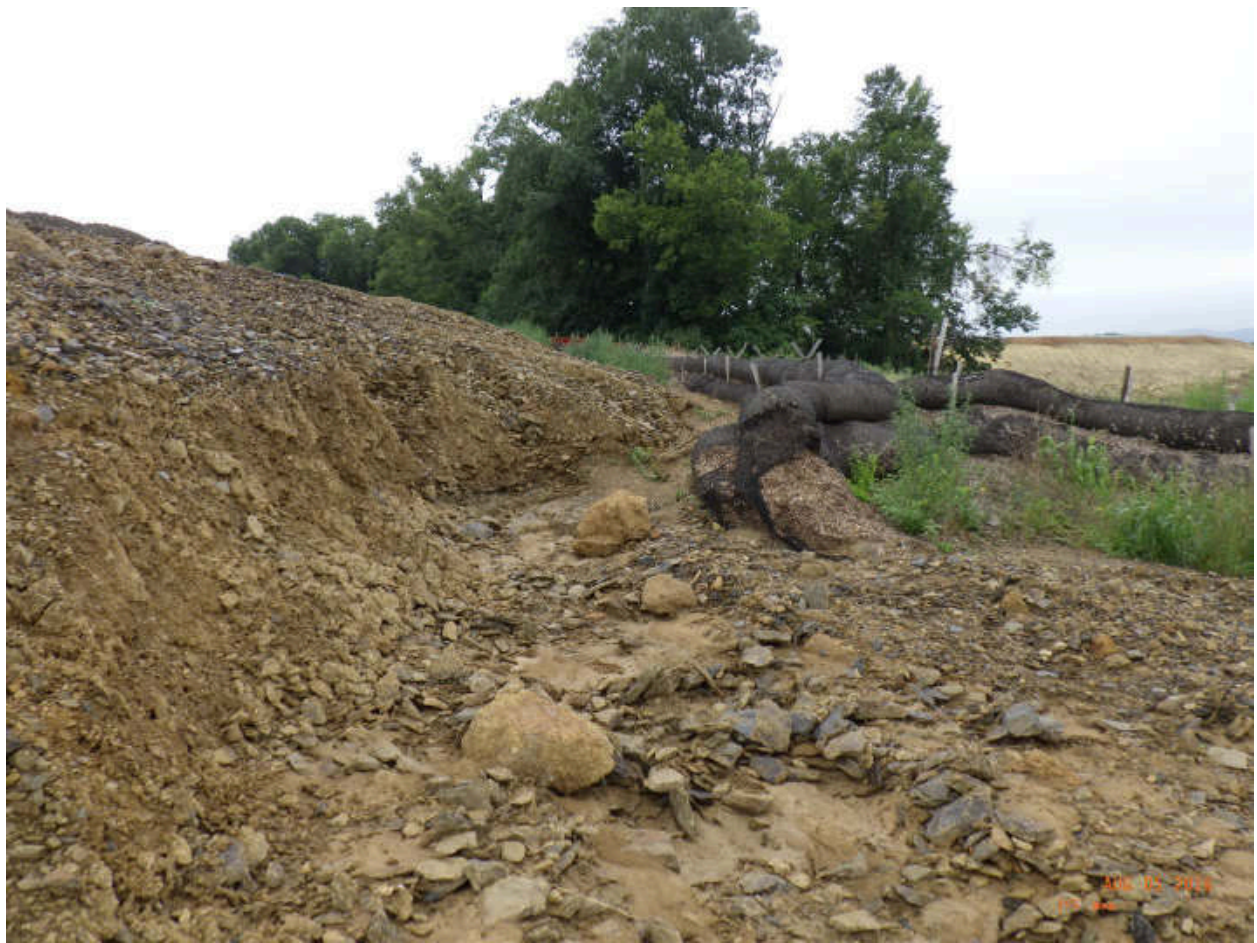
Photo 19

8. CFS #9 was visually observed to be overtopped and undercut. Sedimentation was visible within the boundary of Wetland Y; however, the relationship between this sediment and nearby controls could not be determined with certainty during this inspection. No visual evidence indicated sediment movement beyond the LOD boundary or reaching discharge point 002 at the time of inspection. Photos 19–28.

| <p>- CCCD recommends pumping the water from the Existing PPL Laydown Sediment Basin within 96 hours following a runoff event. This water may be utilized to spray the site to minimize dust. Sediment Basins are to be empty between runoff events. Using the system referenced in observation 3 of this report is ok.</p> <p>- Ensure the site continues to be inspected weekly and after each measurable runoff event (&gt;0.25 inches).</p> <p>- Ensure any area of the site that is idle for four (4) or more days, including stockpiles, is temporarily stabilized.</p> <p>- The observations noted within #6, 7, 8, 9, 10, 12, 13, 14 and 15 should be corrected as soon as possible. Once corrections have been made, the District requests Liberty to send photos of all repairs to the District.</p> | | |

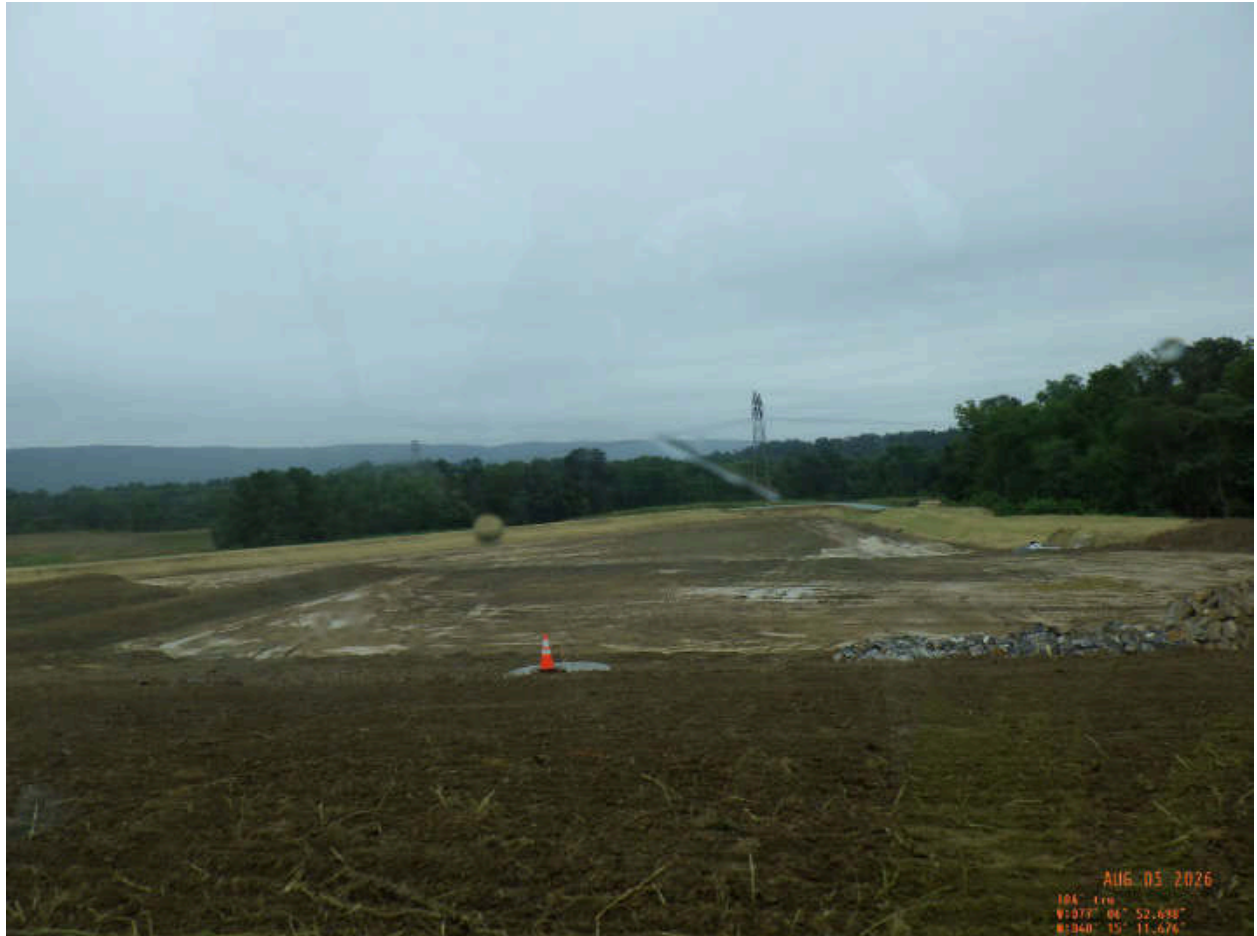
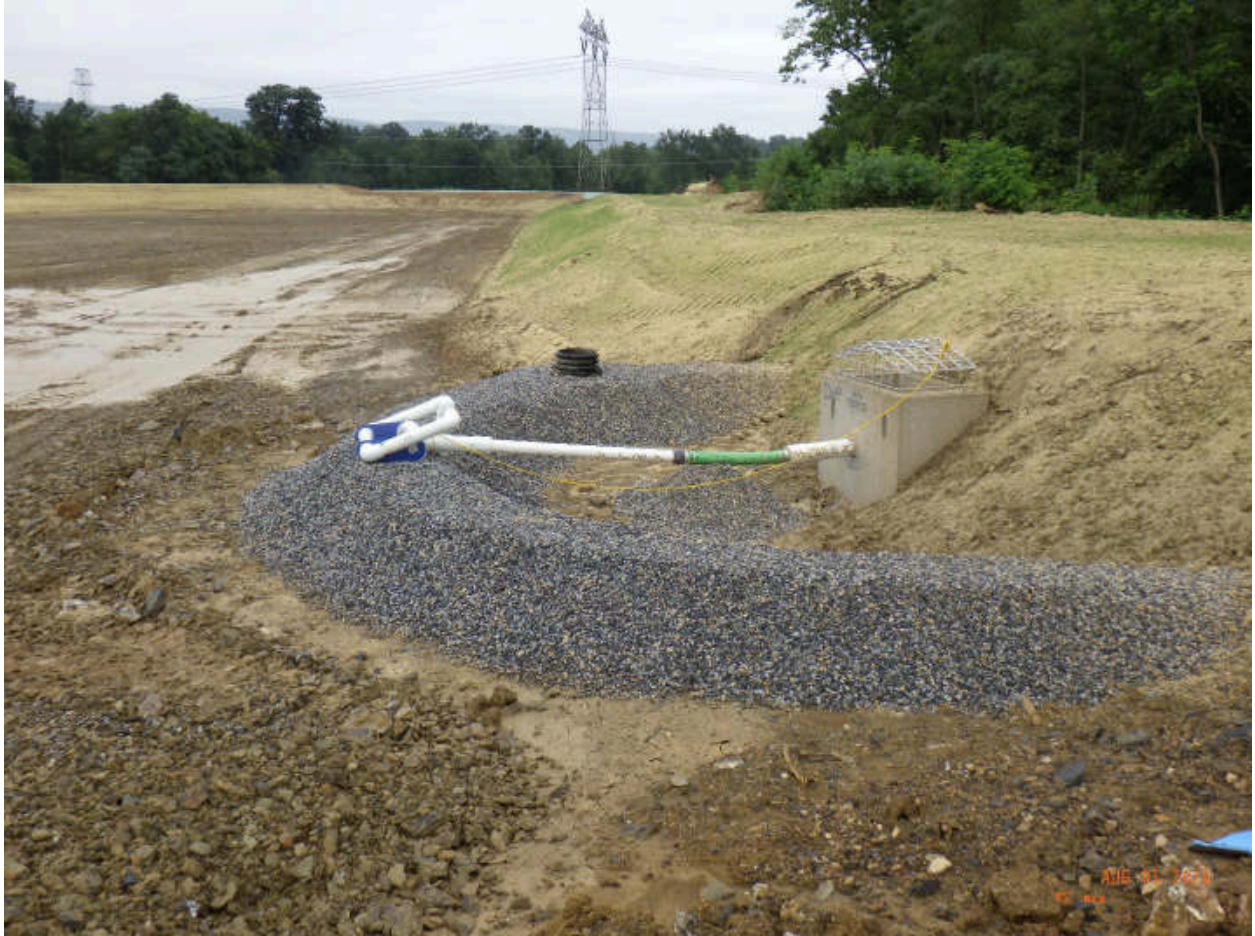
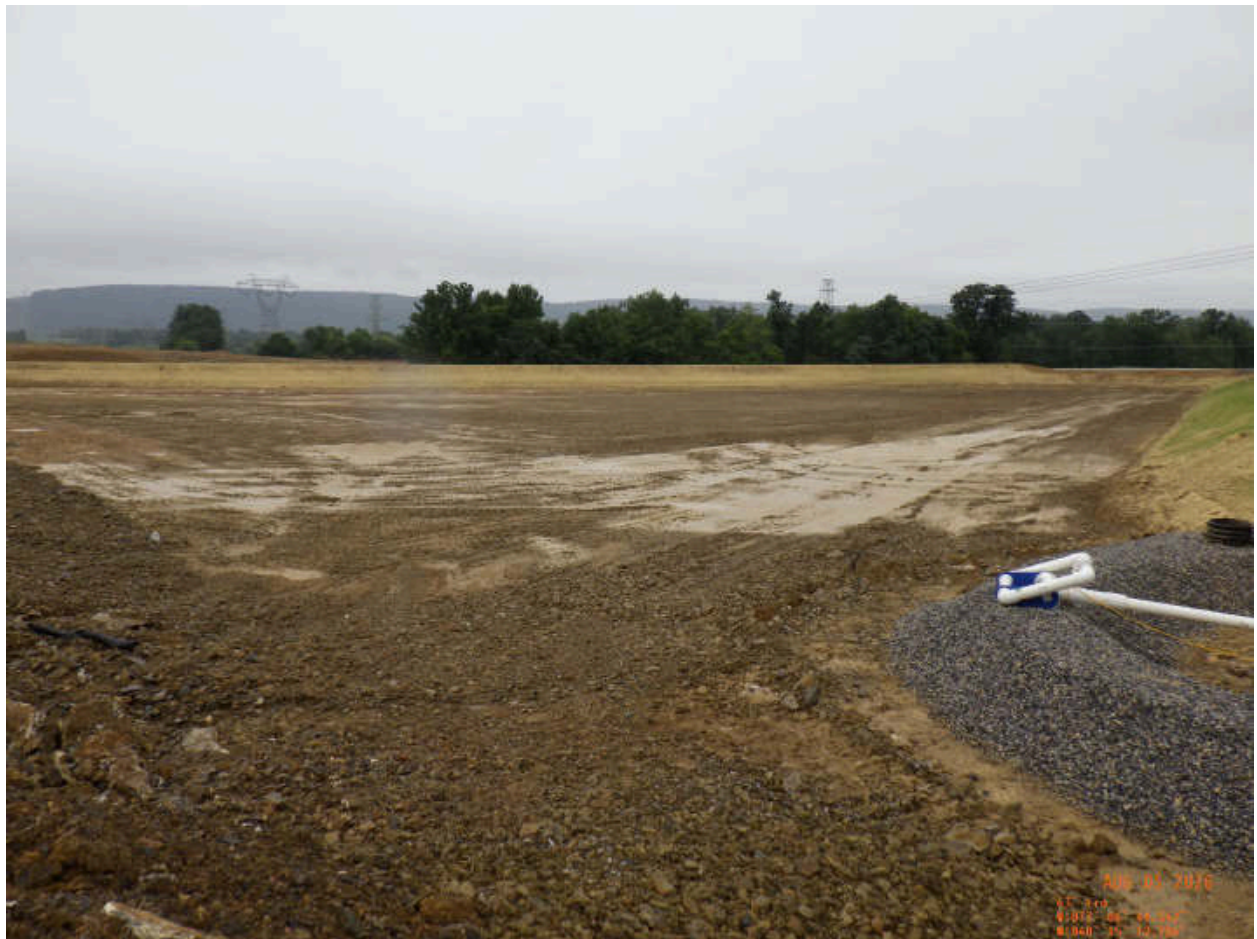
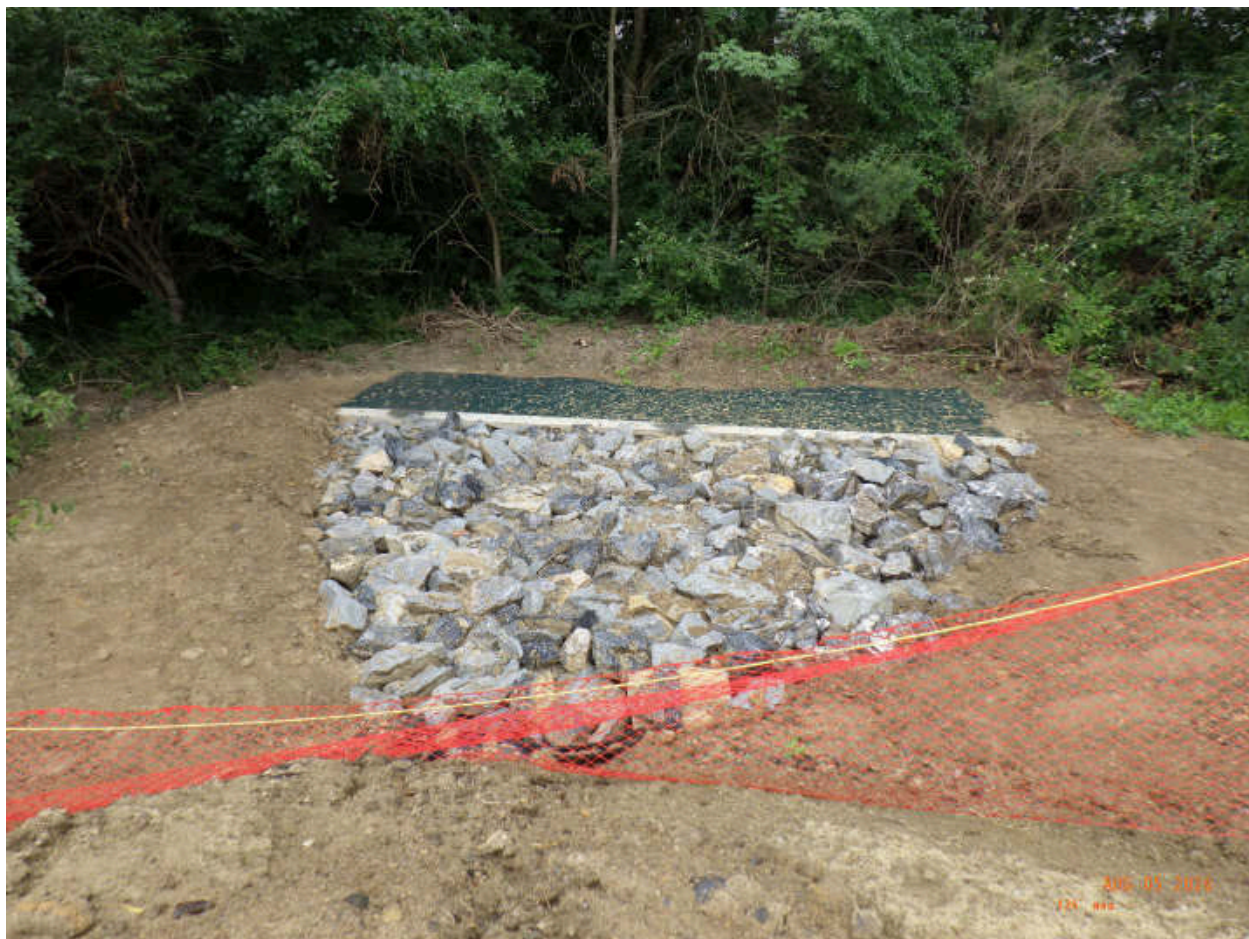
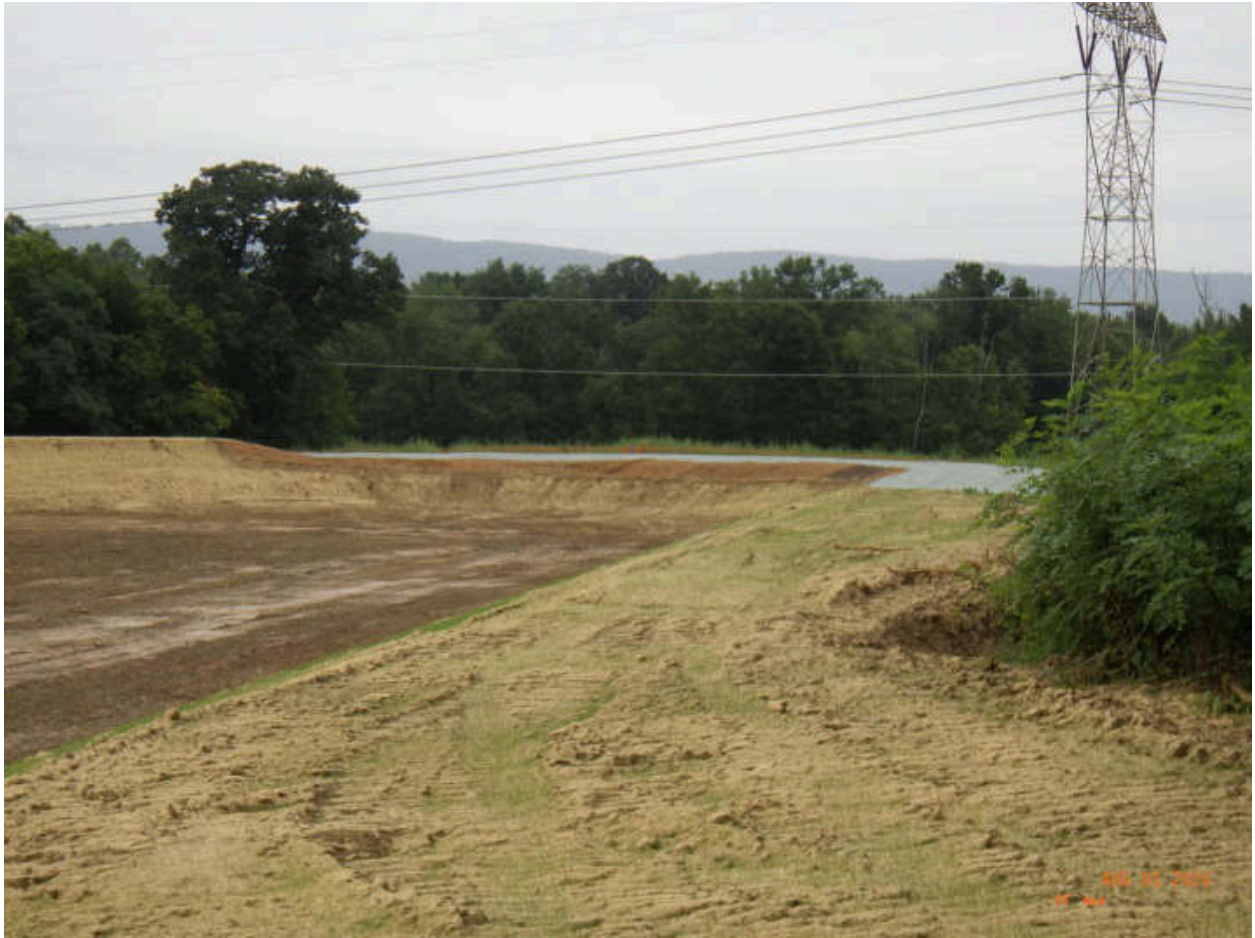
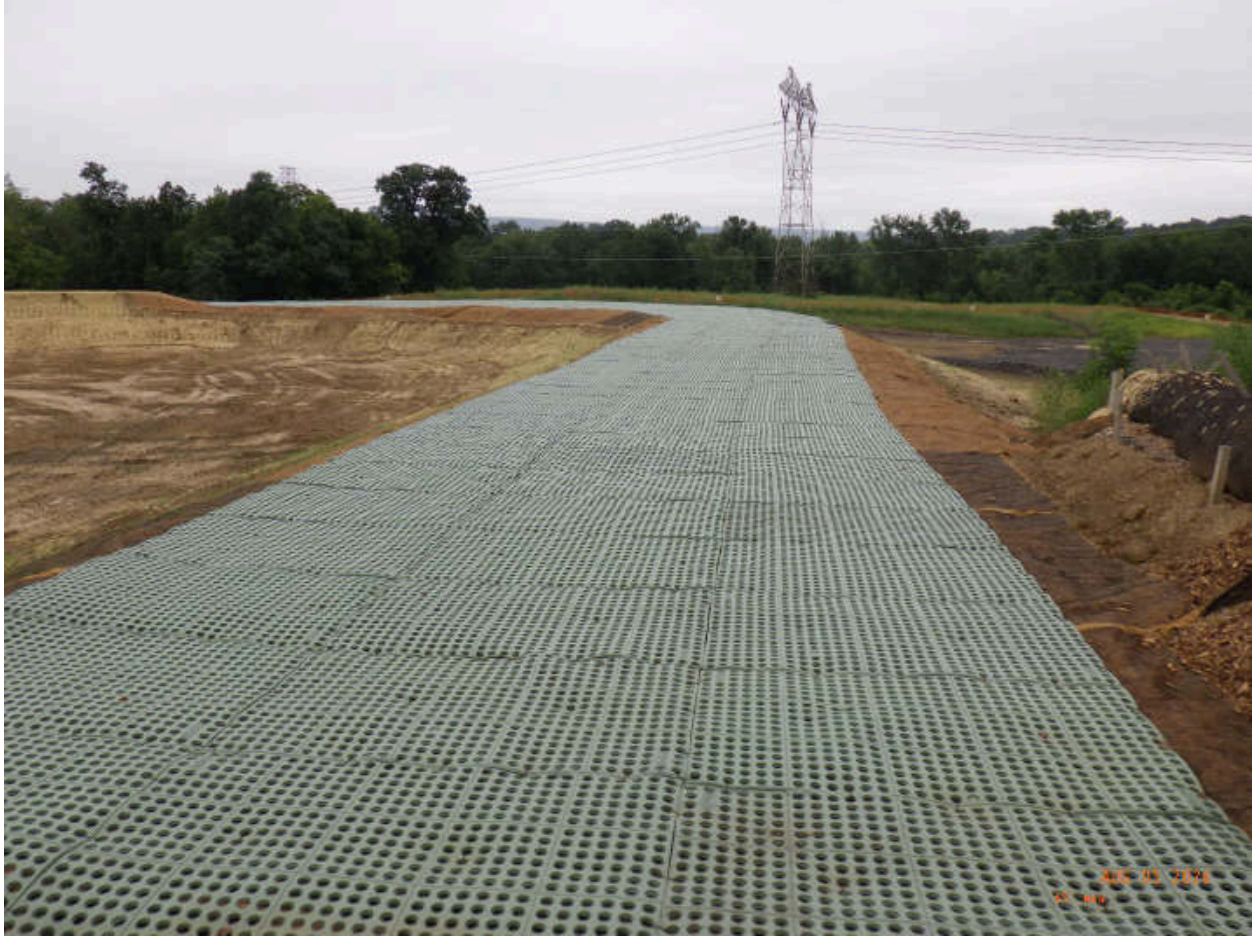
Photo 29

9. Sediment Basin C1 has been constructed with outlet structure OC C1.4 and a skimmer. All seals appeared watertight based on visual observation. The emergency spillway was installed with an appropriate liner. Plywood baffles and sediment clean out stakes were not observed to be installed. A level spreader at the basin's discharge location appeared to be installed consistent with the approved plans. Photos 29–34.
