**Chapter 102 Inspection Report No. 26-02 —  
PAC210079A-4**

CUMBERLAND COUNTY  
CONSERVATION DISTRICT

Re: Pennsylvania Digital 1 (PAX-1)  
NPDES Permit Application No. PAC210079A-4  
Middlesex Township, Cumberland County

## CHAPTER 102 INSPECTION REPORT

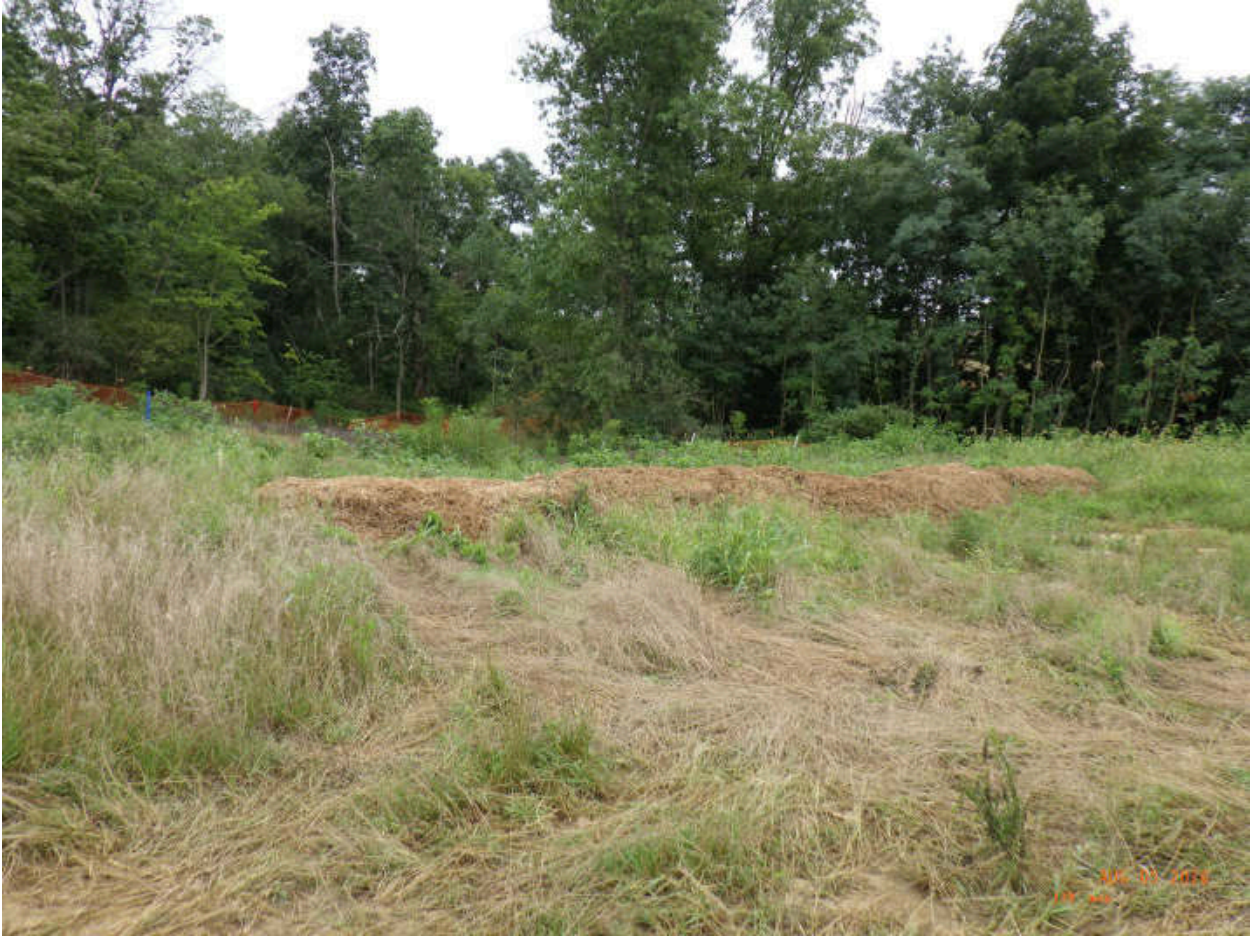
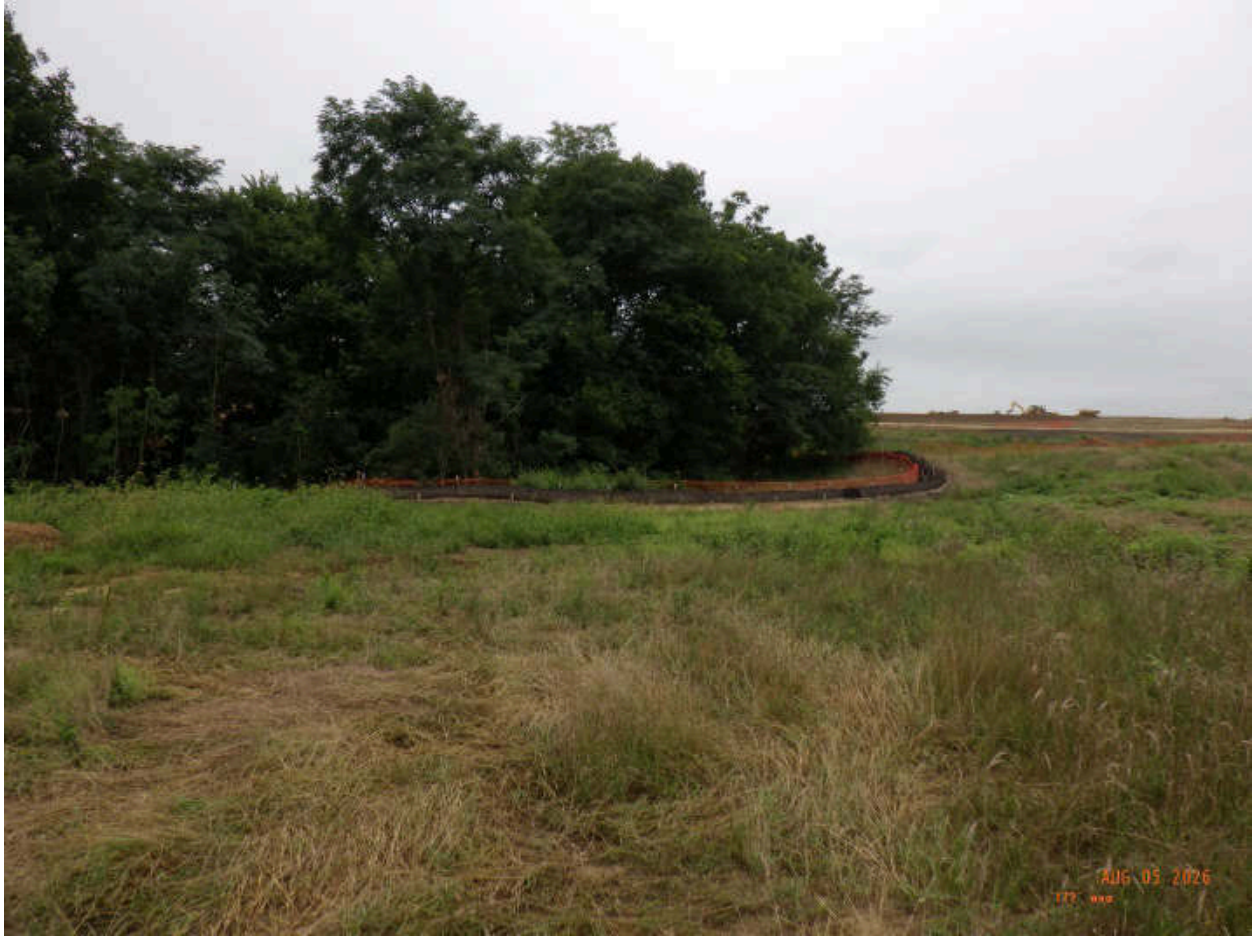
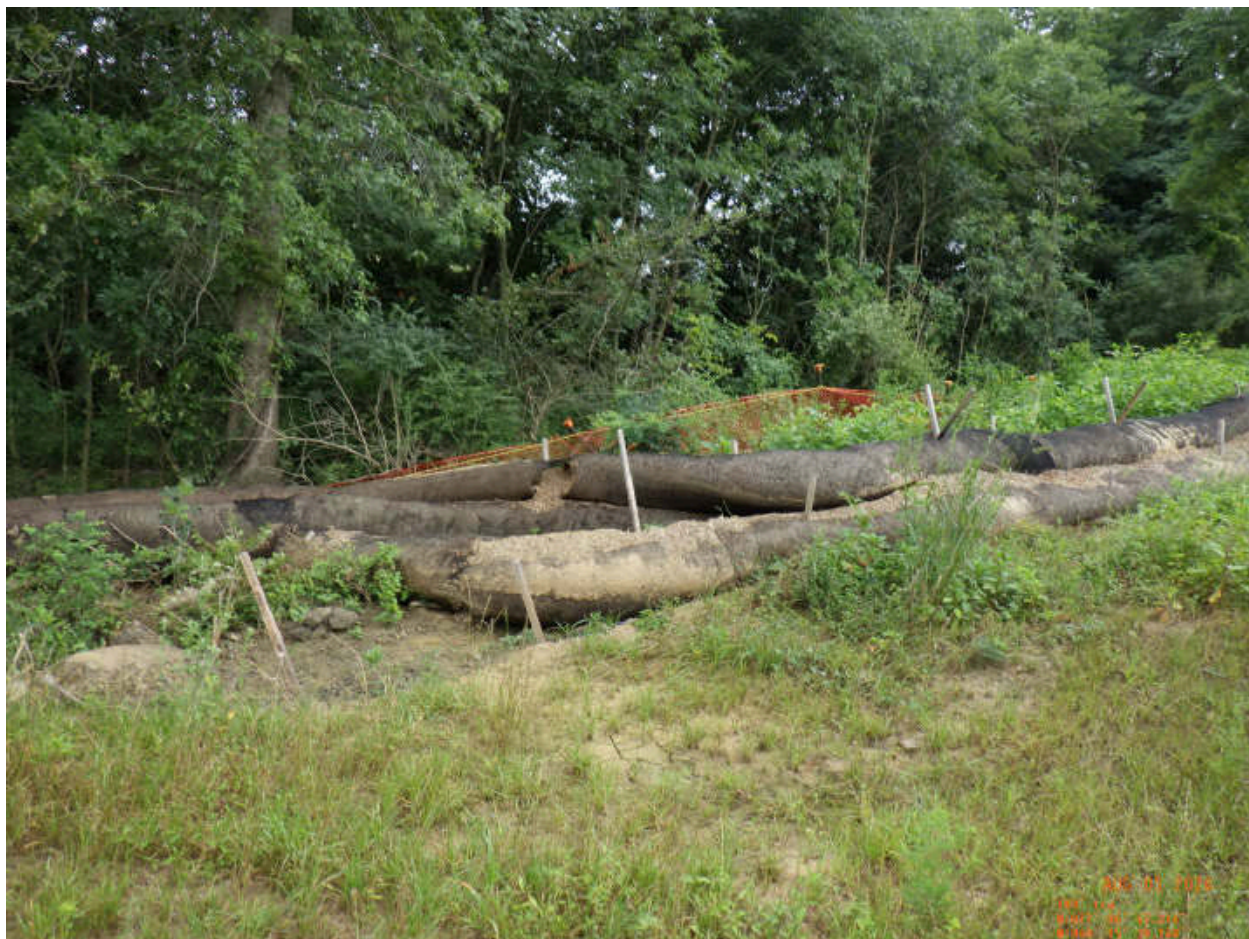
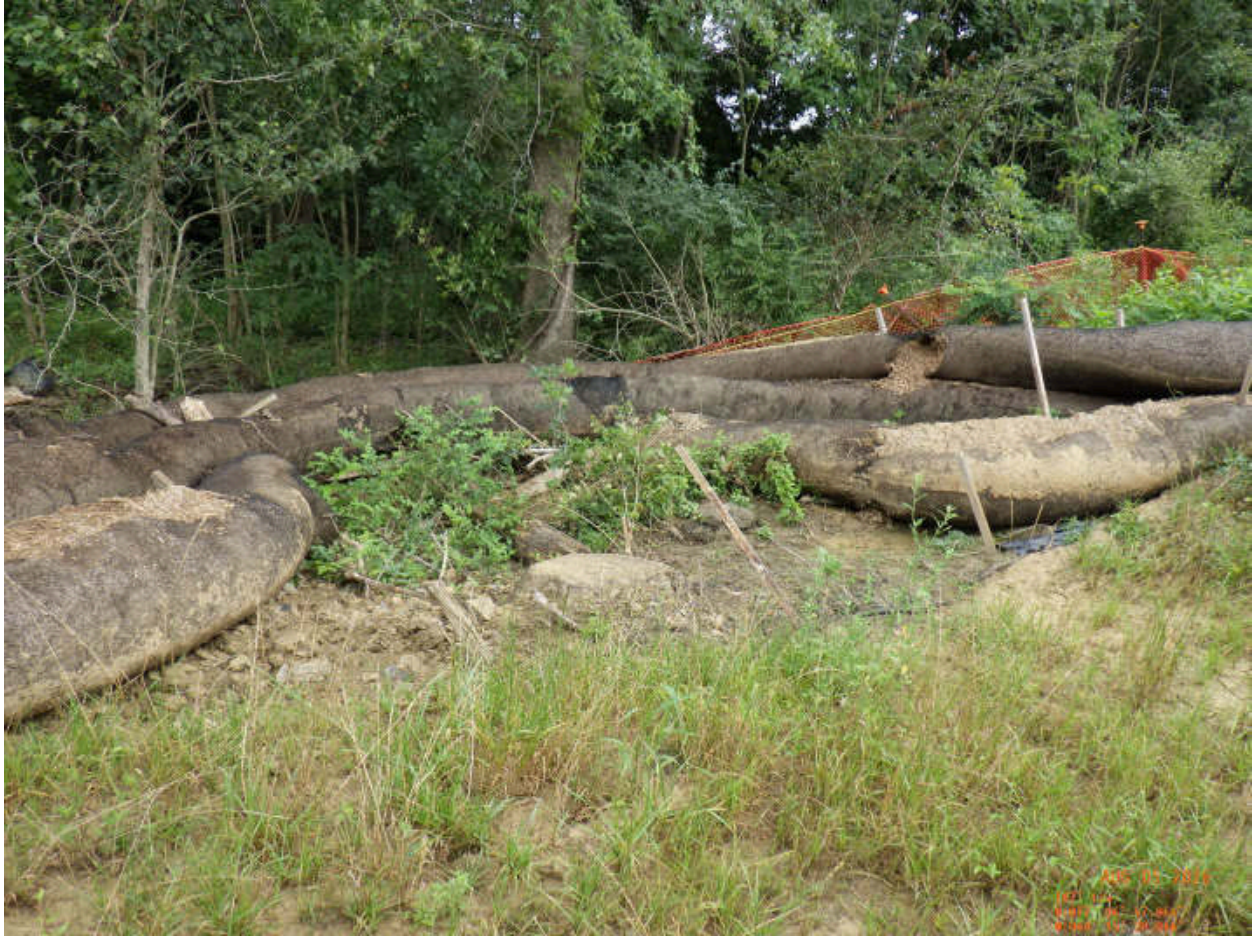
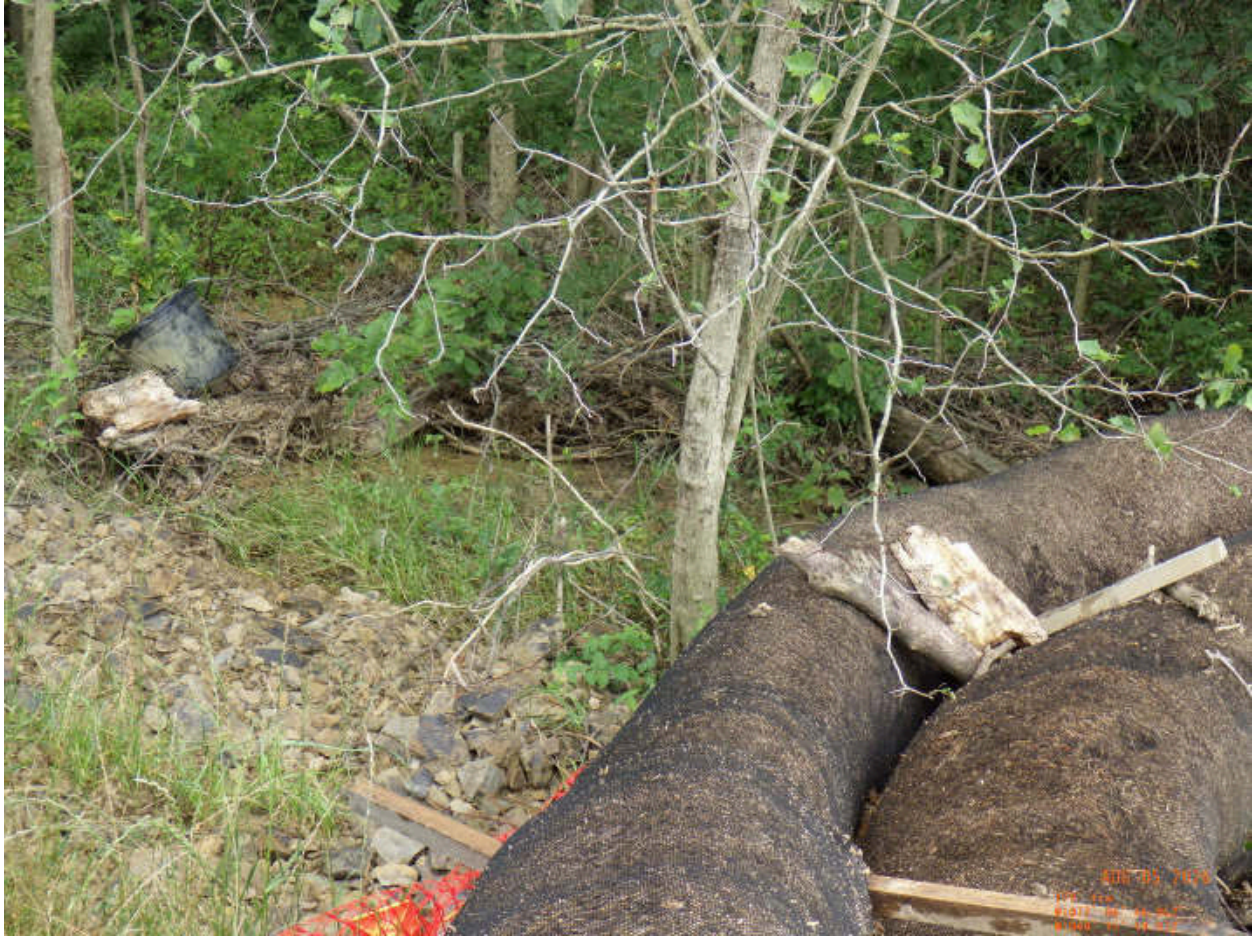
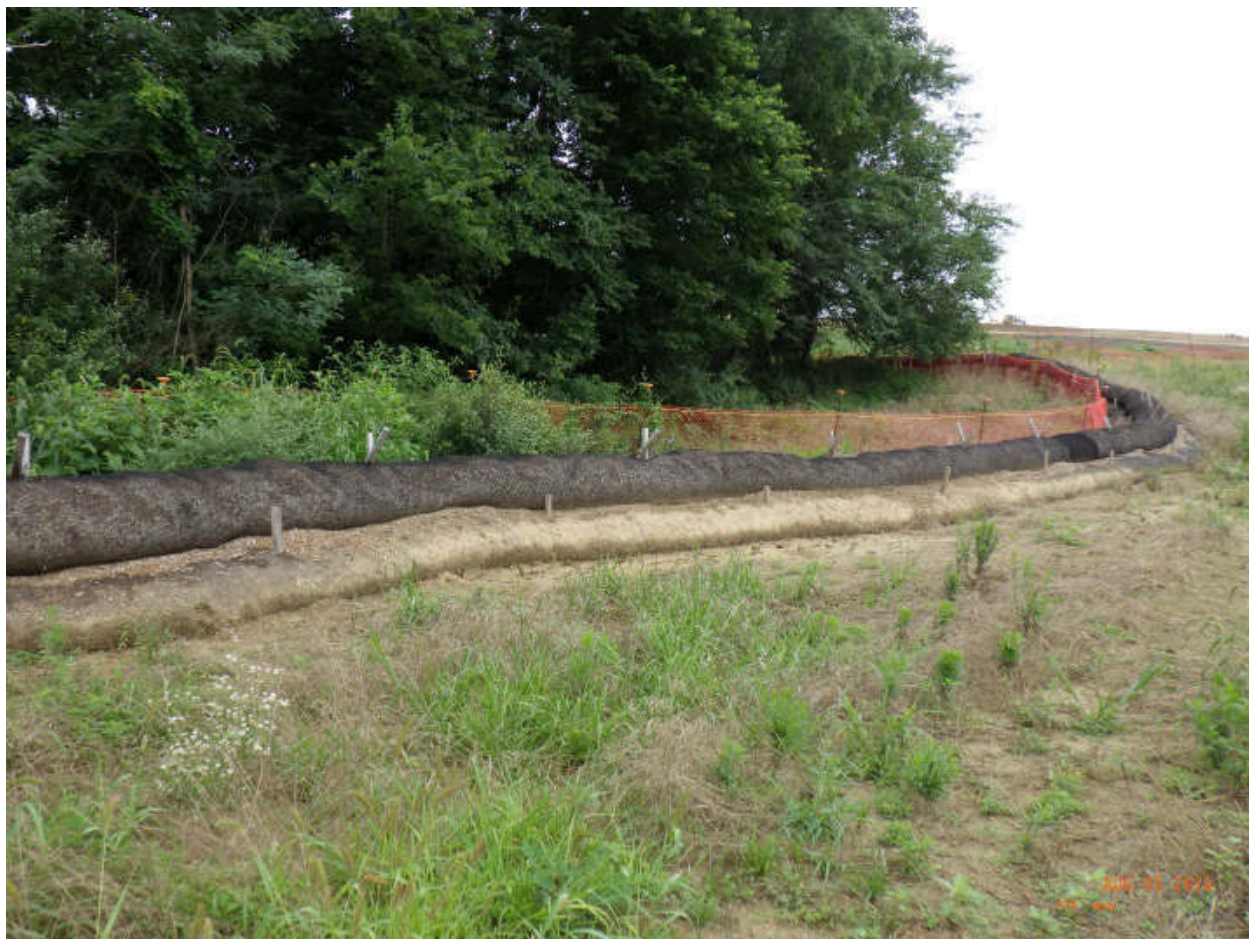
*Photo 35*

10. CFS #68 was visually observed to be dislodged and appeared to have overtopped. No evidence was observed indicating sediment movement outside of the LOD boundary during this inspection. Photos 35–39 and 41.

| <p>- CCCD recommends pumping the water from the Existing PPL Laydown Sediment Basin within 96 hours following a runoff event. This water may be utilized to spray the site to minimize dust. Sediment Basins are to be empty between runoff events. Using the system referenced in observation 3 of this report is ok.</p> <p>- Ensure the site continues to be inspected weekly and after each measurable runoff event (&gt;0.25 inches).</p> <p>- Ensure any area of the site that is idle for four (4) or more days, including stockpiles, is temporarily stabilized.</p> <p>- The observations noted within #6, 7, 8, 9, 10, 12, 13, 14 and 15 should be corrected as soon as possible. Once corrections have been made, the District requests Liberty to send photos of all repairs to the District.</p> | | |

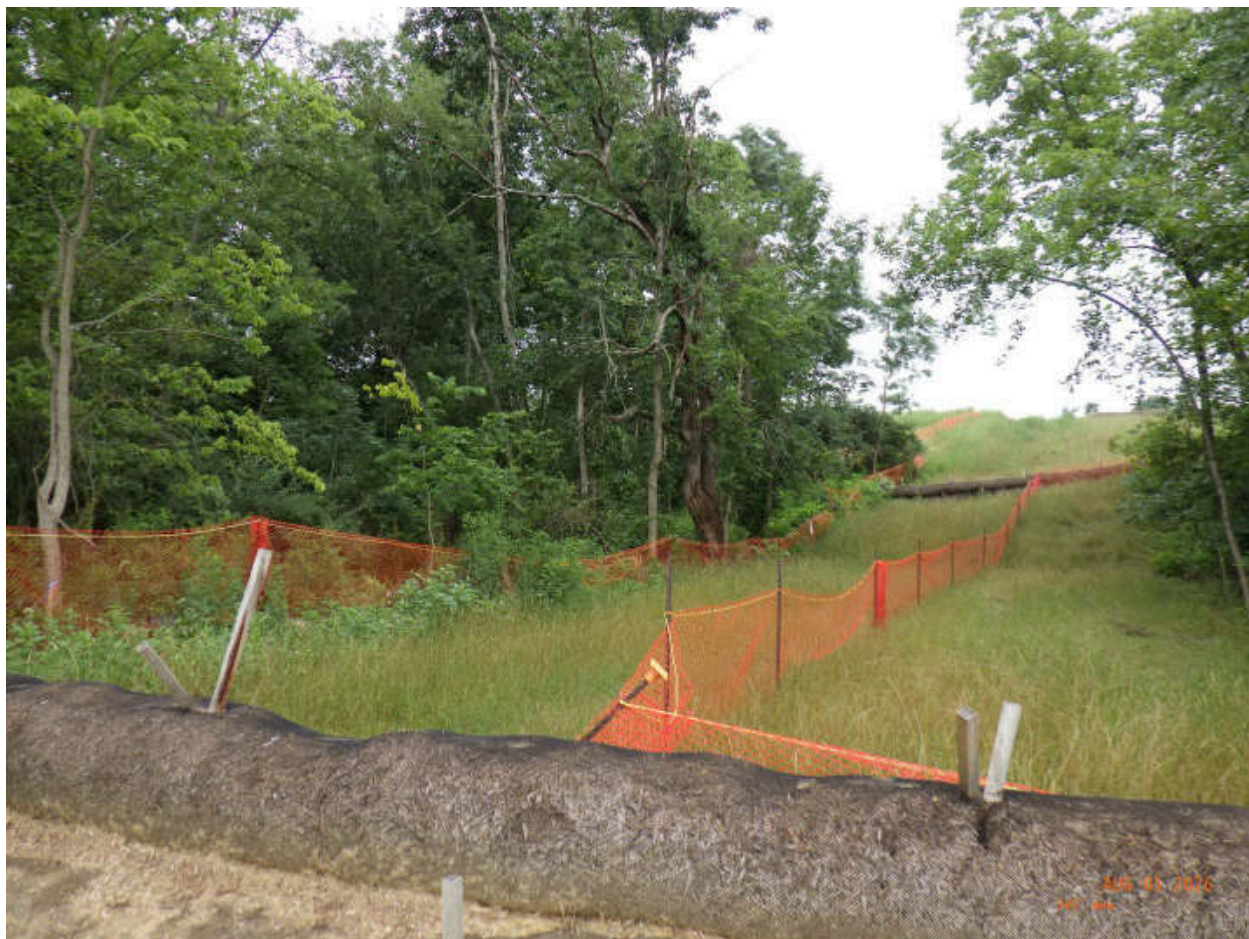
Photo 40

11. Disturbances associated with the waterline relocation, conducted during March–April 2026, appeared to have achieved adequate perennial vegetation coverage based on visual observation. Photo 40.

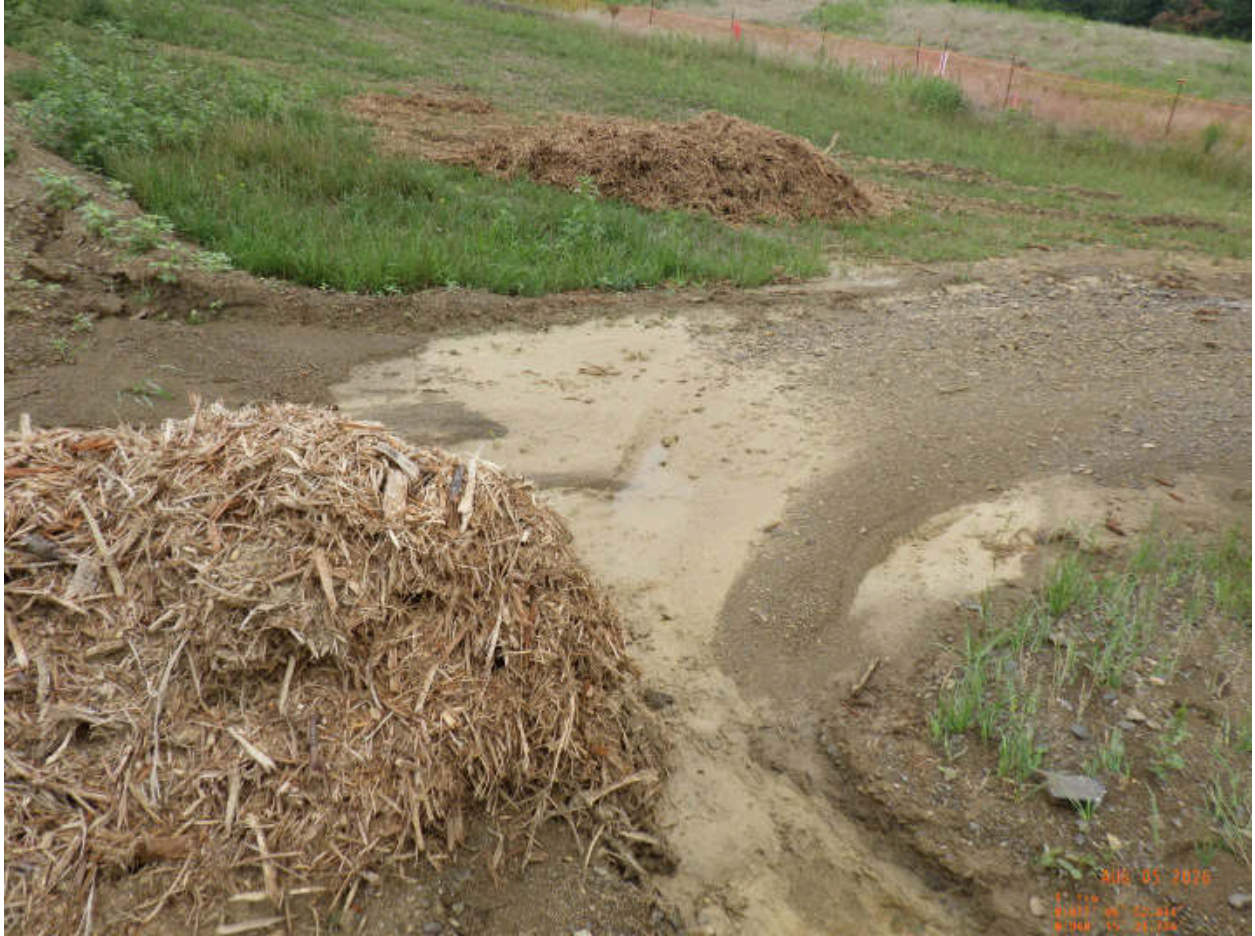
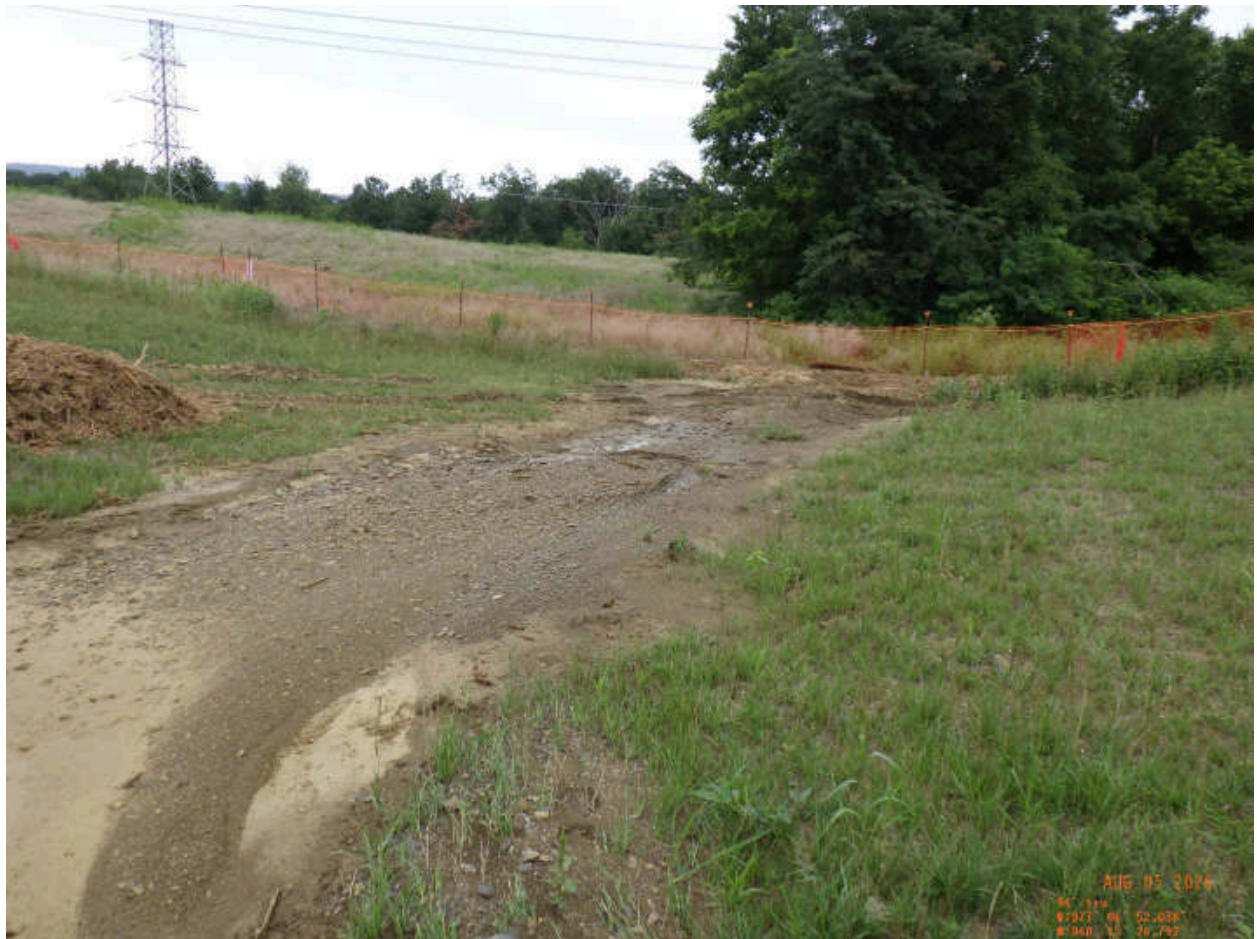
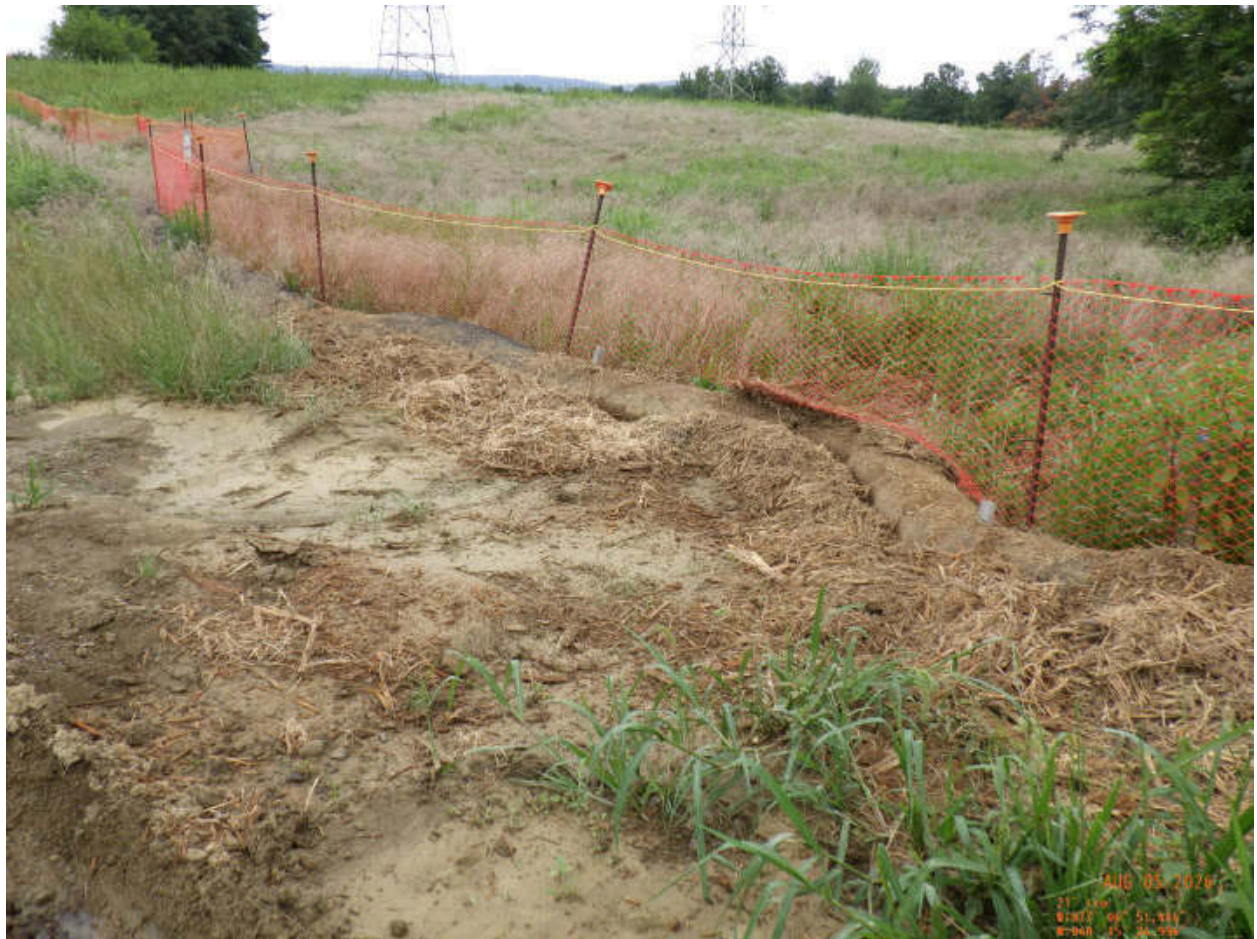
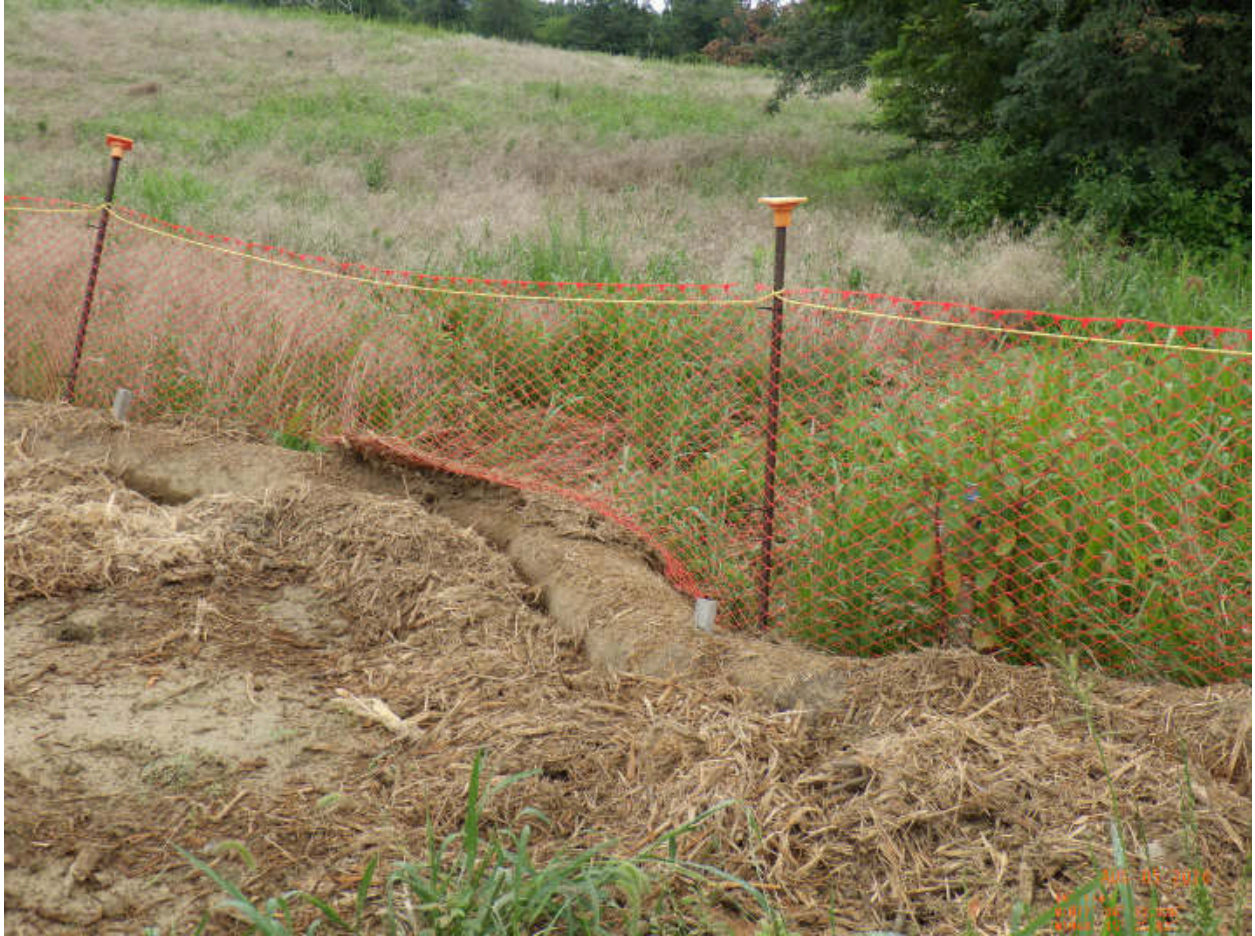
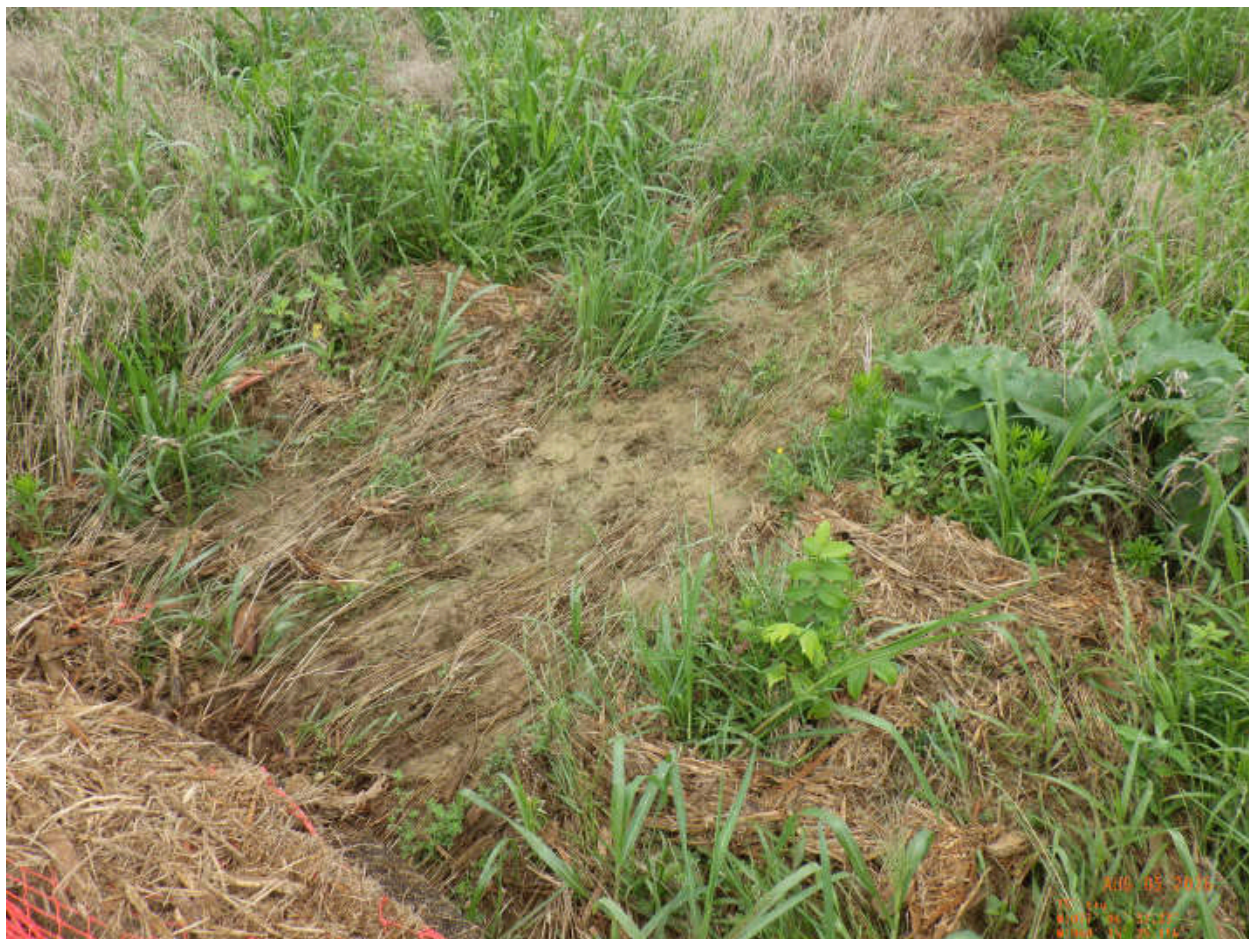
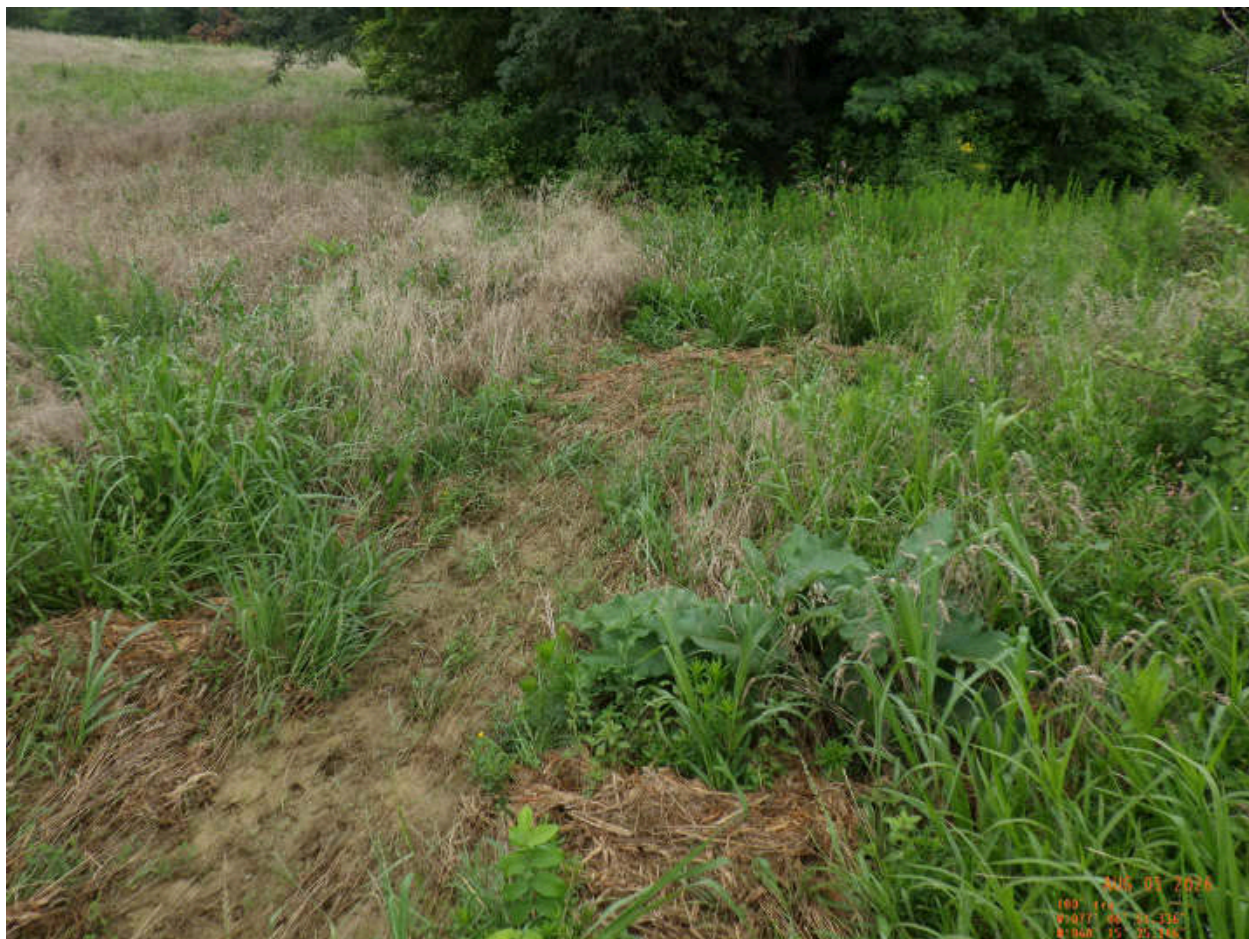
Photo 42

12. CFS #72 appeared to have overtopped during the most recent storm event. Sediment was visually observed near discharge point 024; no observable evidence indicated sediment reaching surface water identified as “channel 04” at the time of inspection. Photos 42–47.

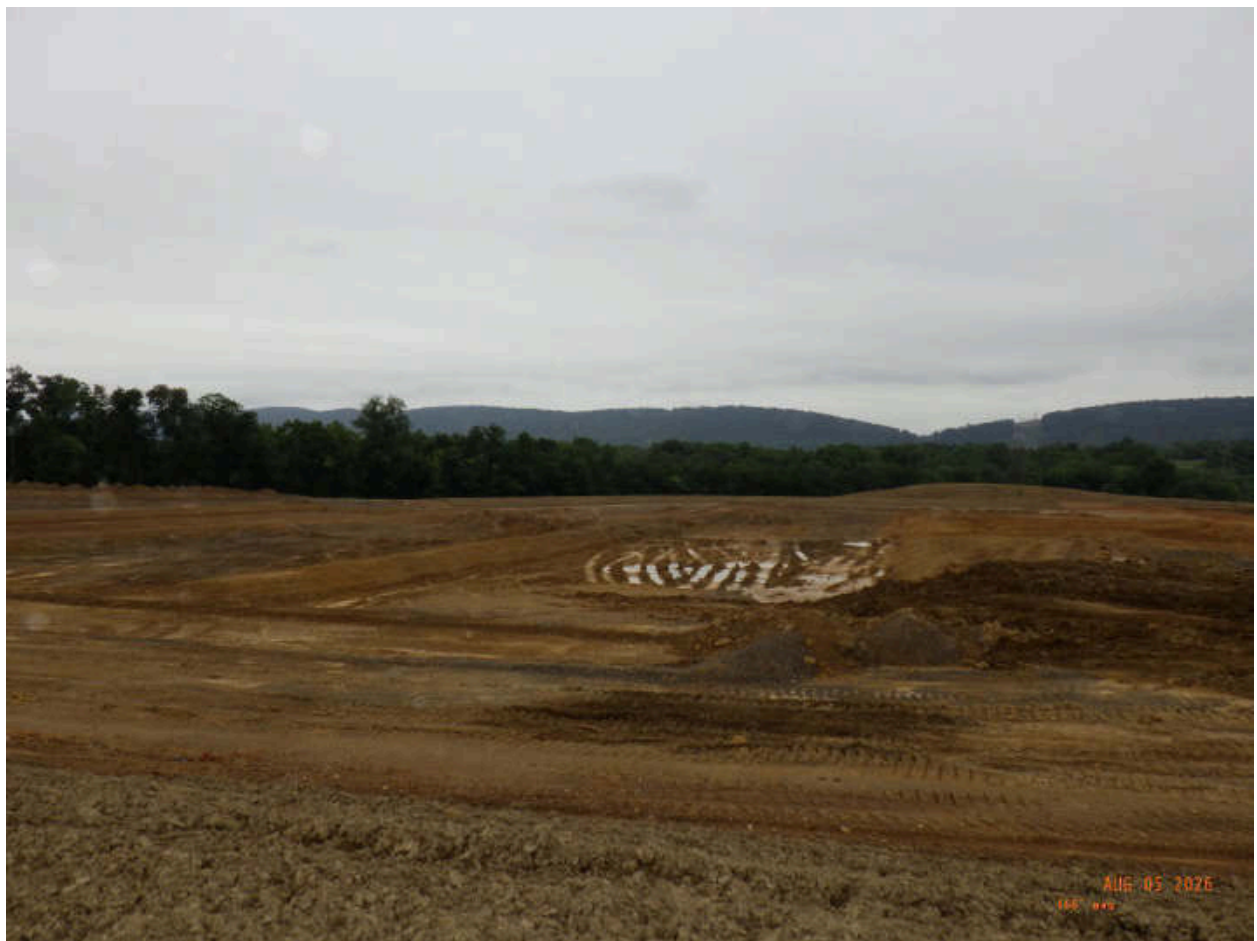
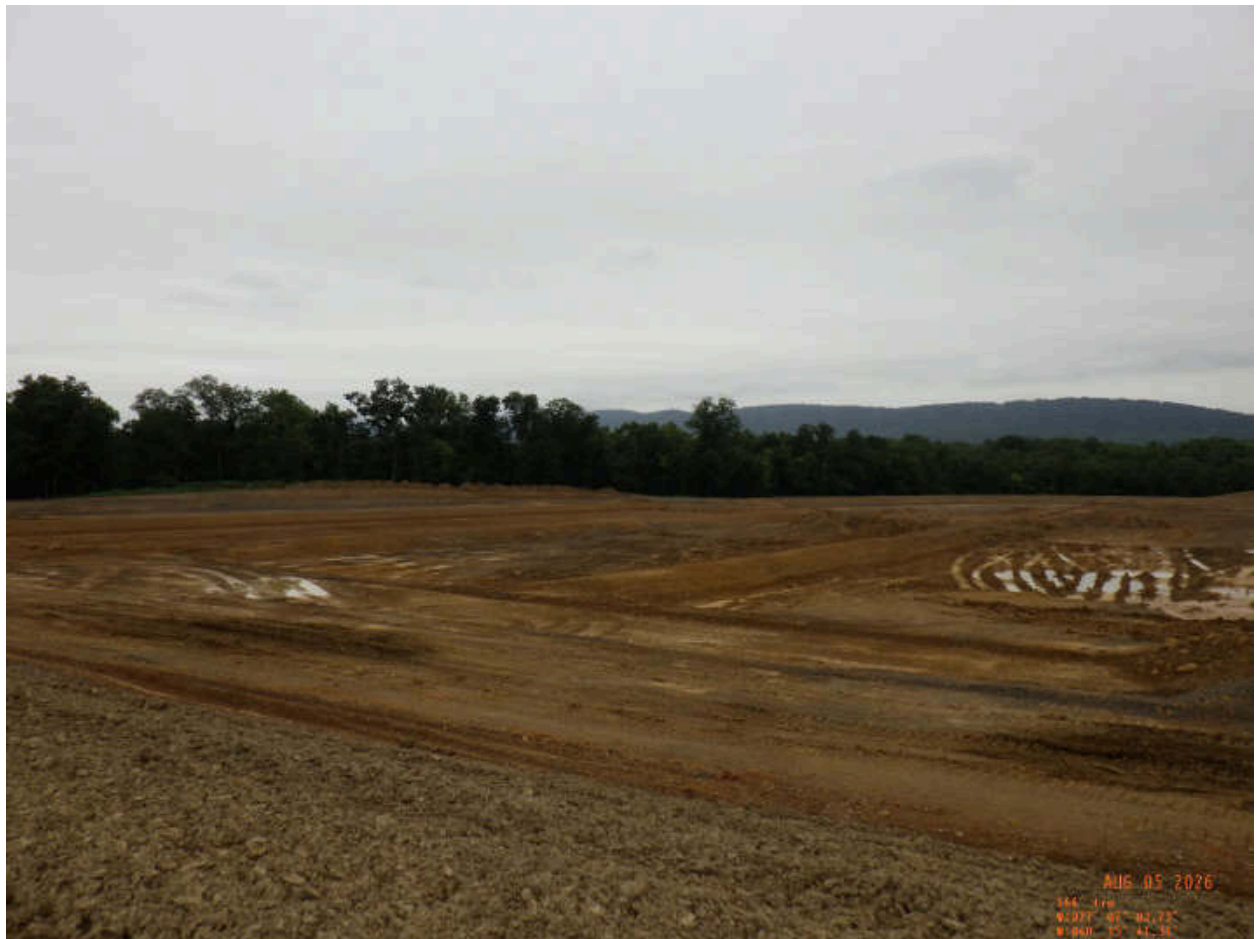
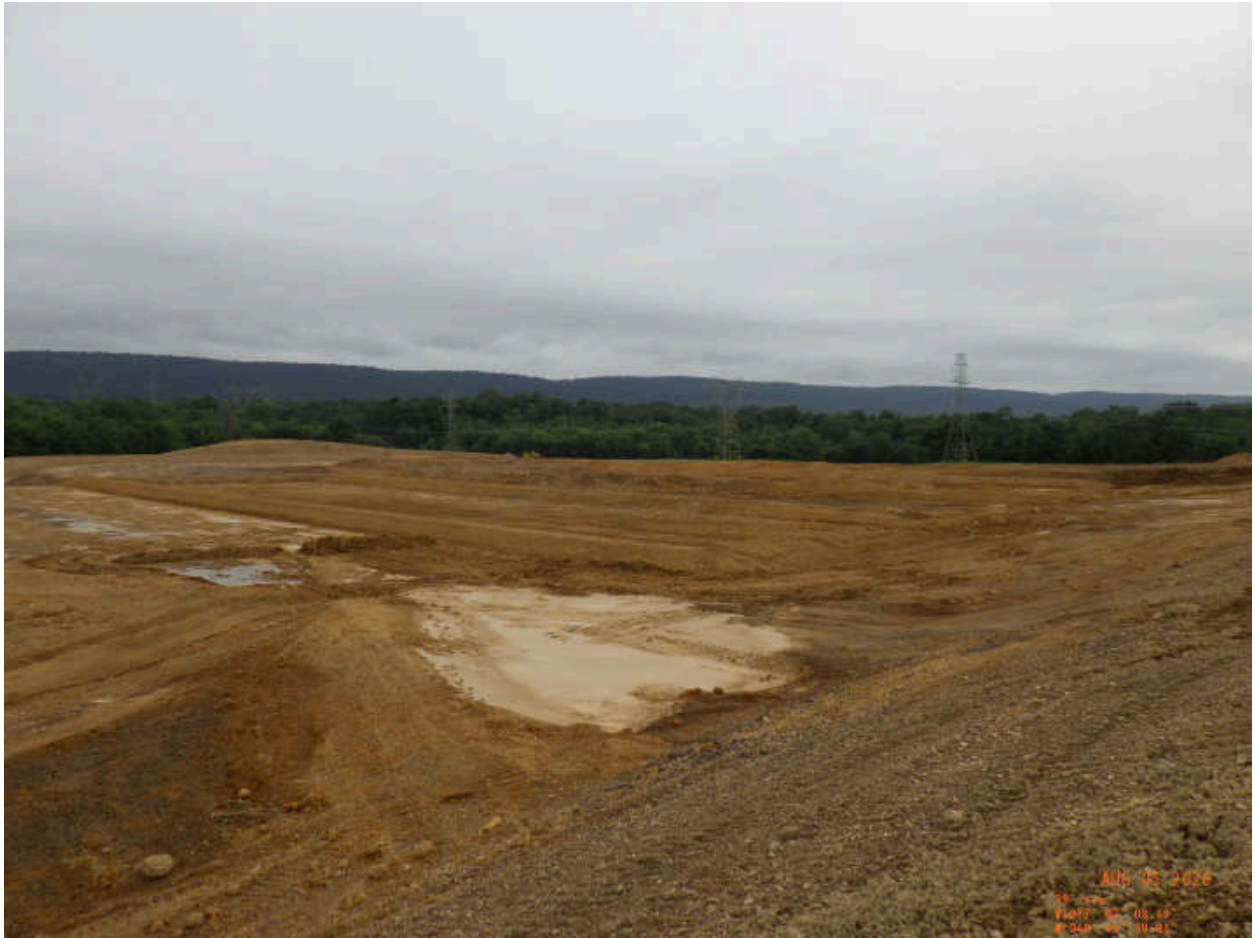
Photo 48

13. Sediment Basin K1 was observed to be under construction. The outlet structure, baffles, and sediment clean out stakes did not appear to be installed at the time of inspection. Liberty reported that a plan or construction sequence modification may be needed due to the planned retaining wall on the basin's southern side, which they stated may limit access once installed. Any modification would need to be coordinated and submitted by the design engineer. Photos 48, 49 & 58.

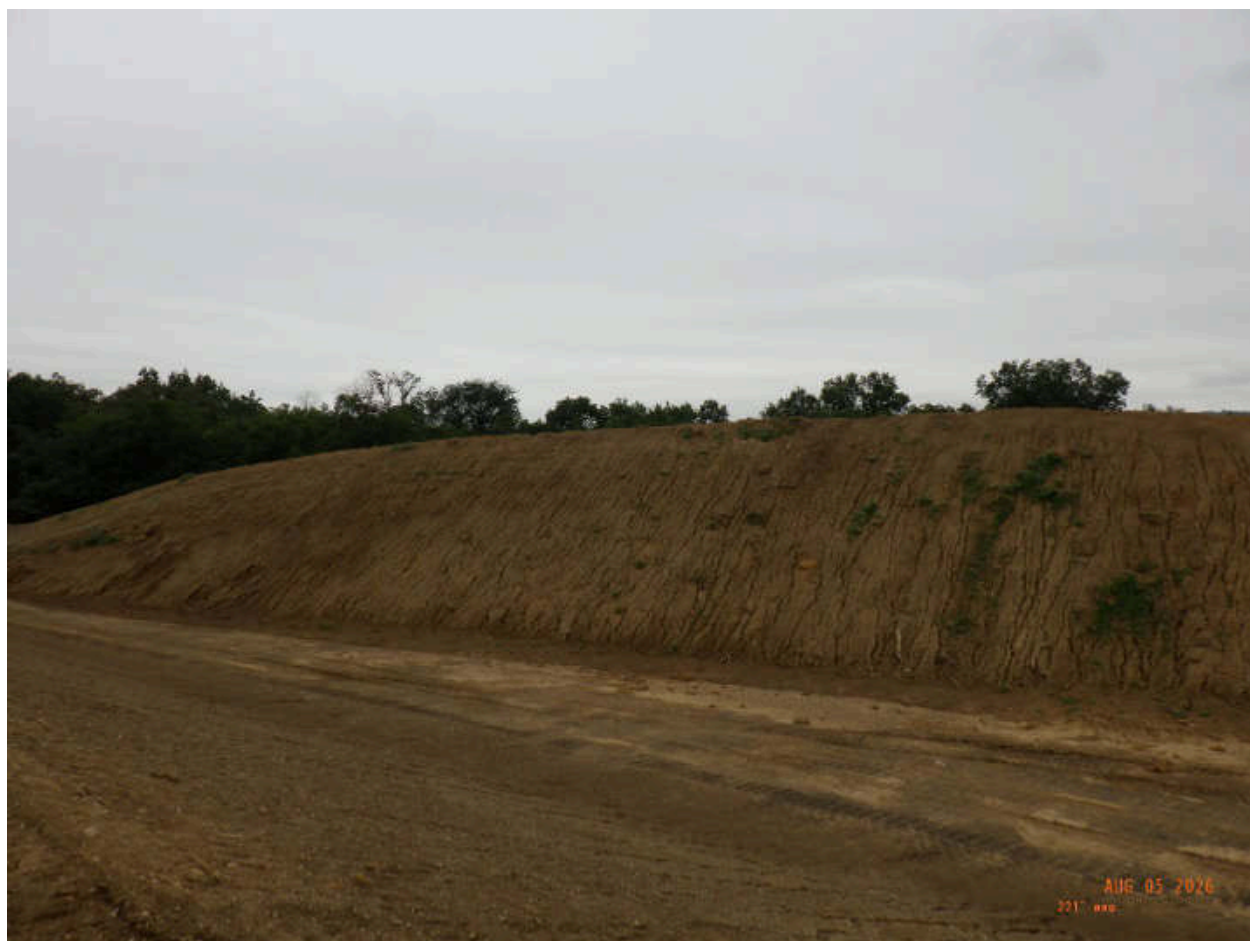
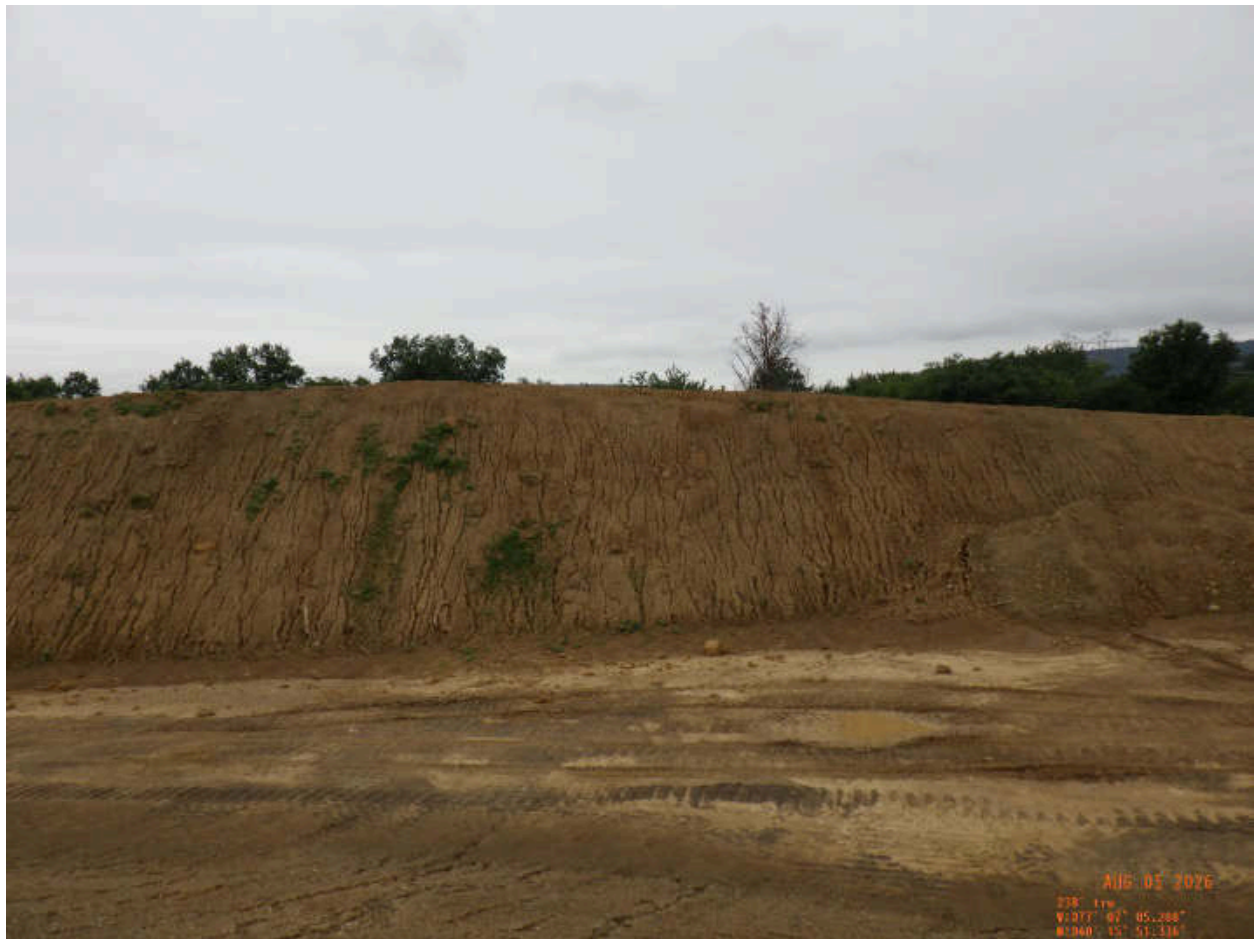
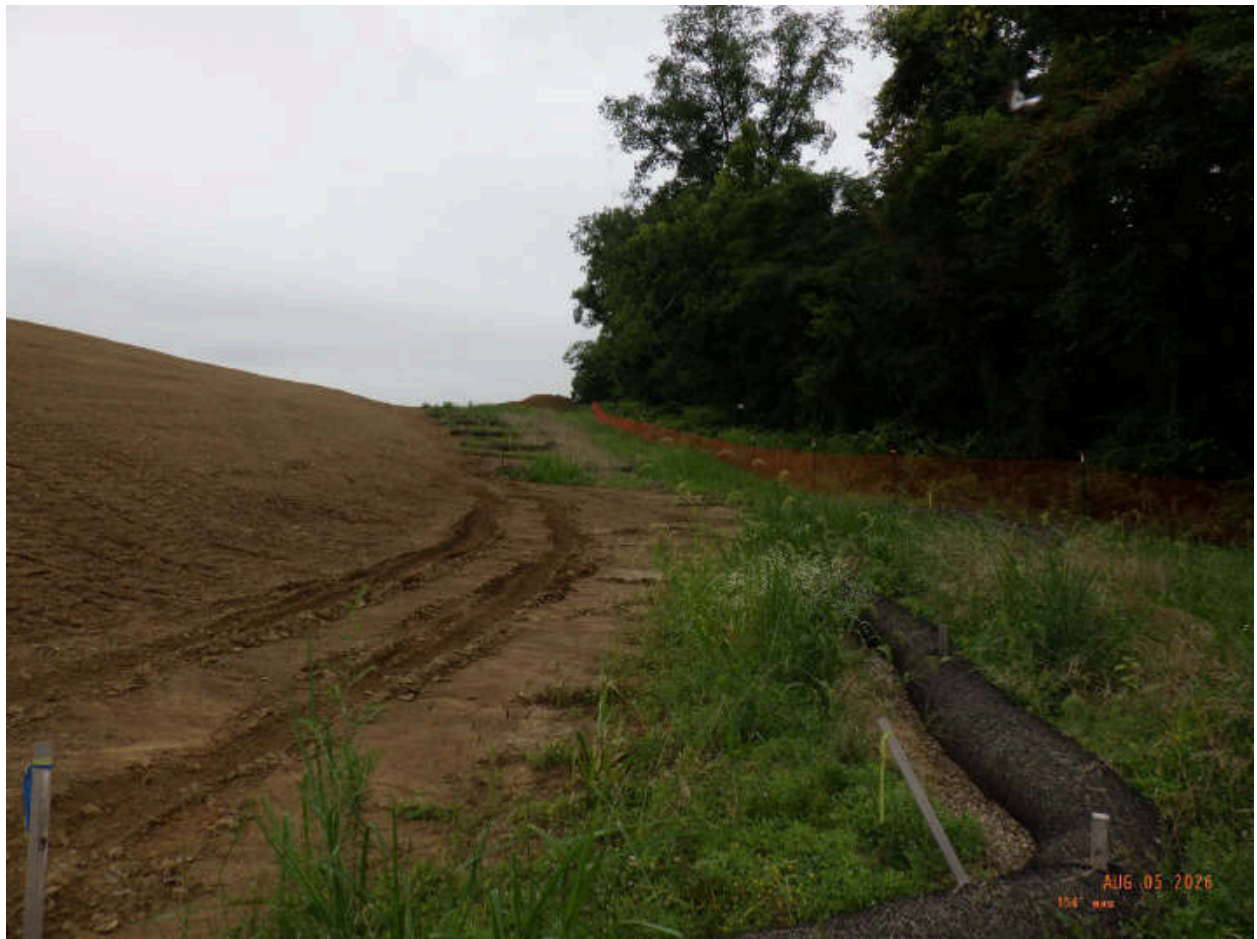
*Photo 50*

14. The north side of the topsoil pile located north of Sediment Basin K1 appeared to lack temporary stabilization. Although the topsoil pile remains active, perimeter E&S controls were visually observed to be accumulating sediment. Photos 50–52.
