**Chapter 102 Inspection Report No. 26-02 —  
PAC210079A-4**

CUMBERLAND COUNTY  
CONSERVATION DISTRICT

Re: Pennsylvania Digital 1 (PAX-1)  
NPDES Permit Application No. PAC210079A-4  
Middlesex Township, Cumberland County

## CHAPTER 102 INSPECTION REPORT

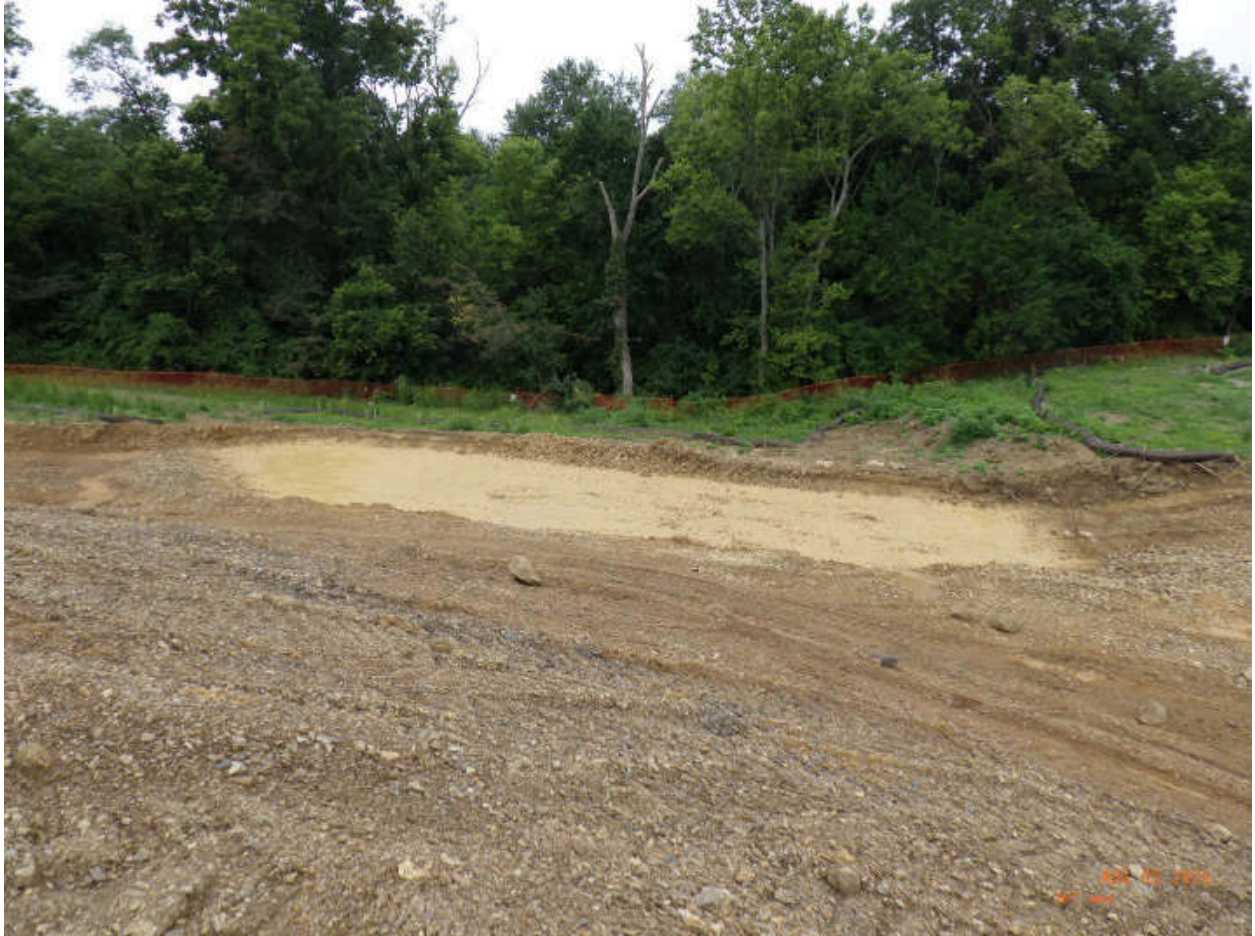
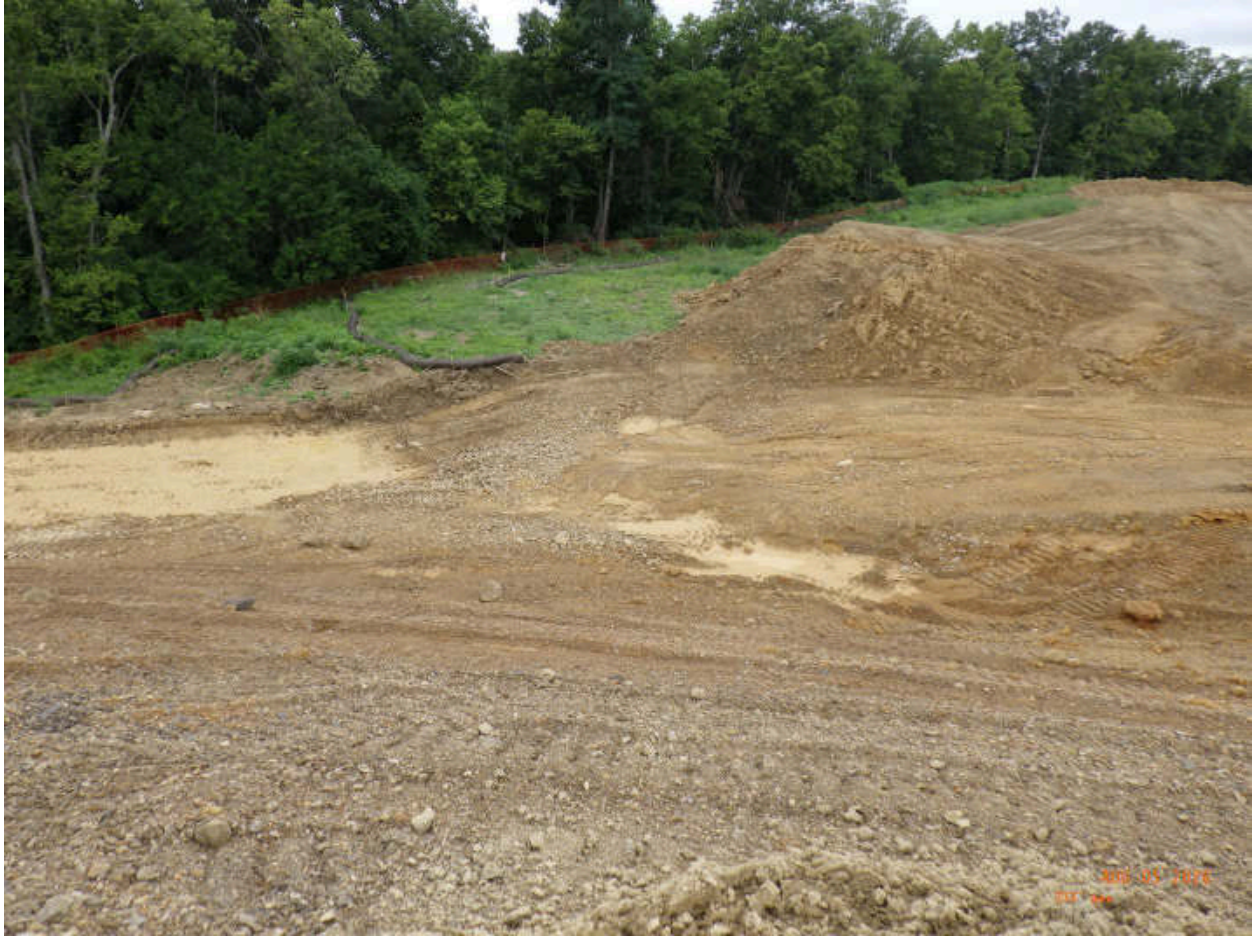
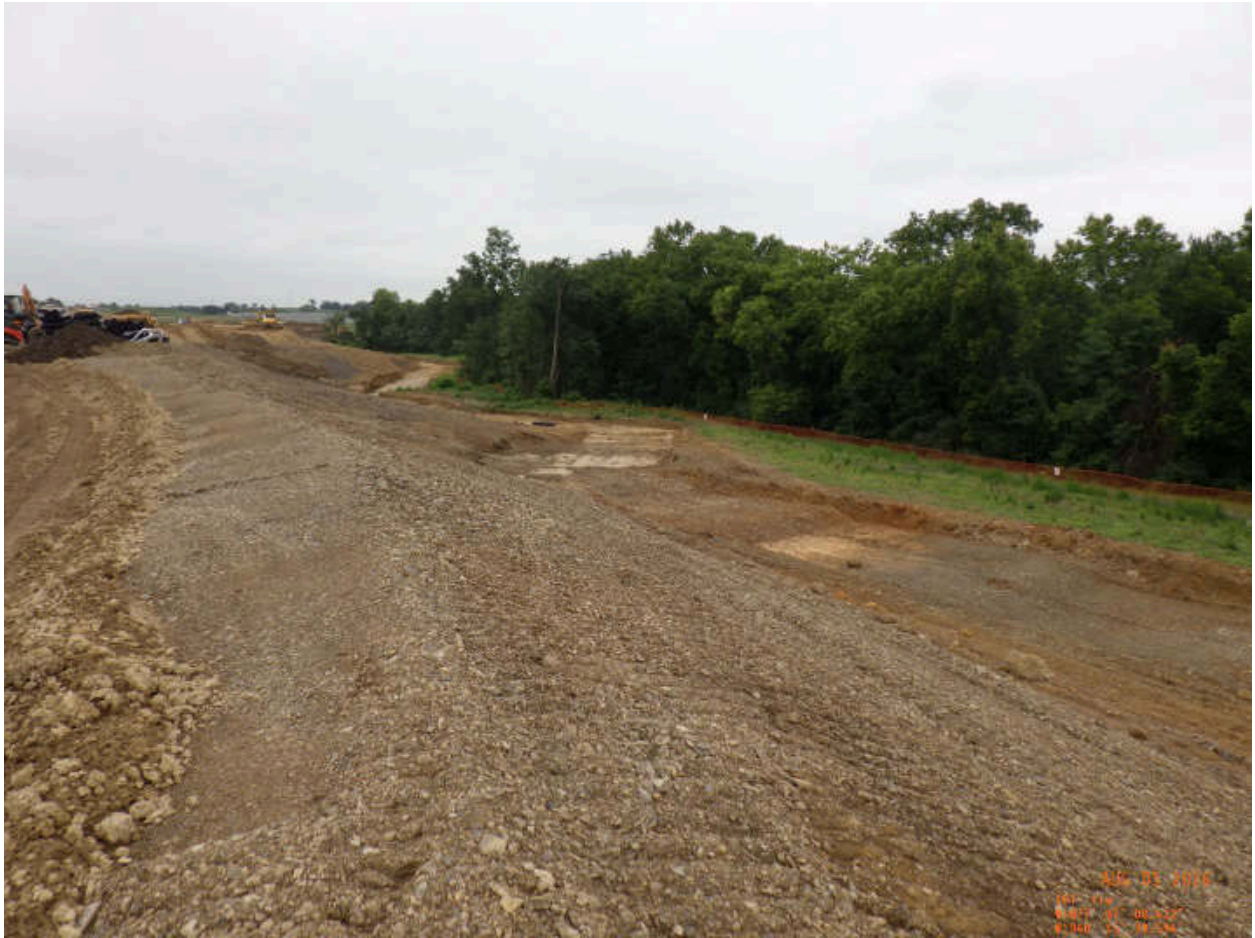
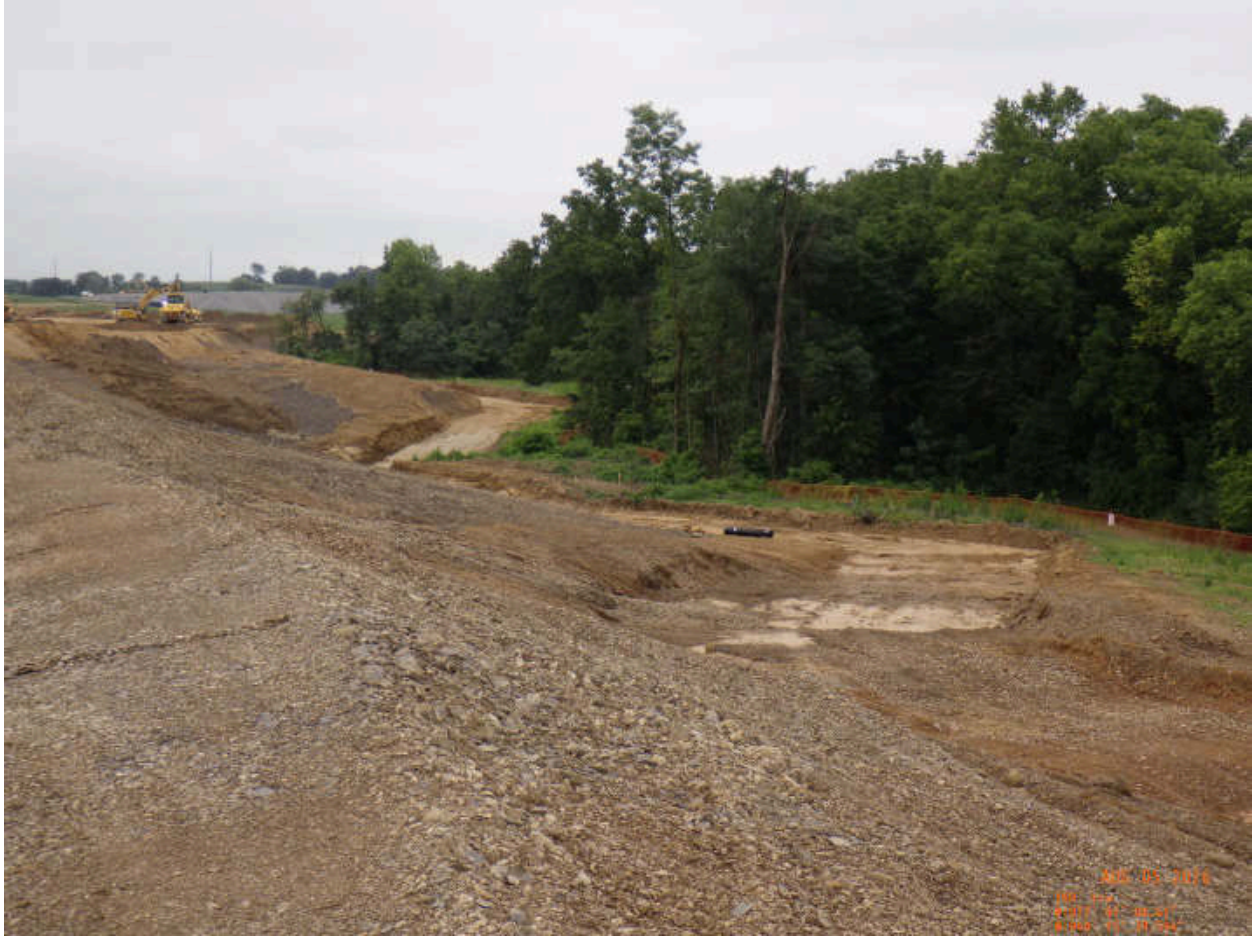
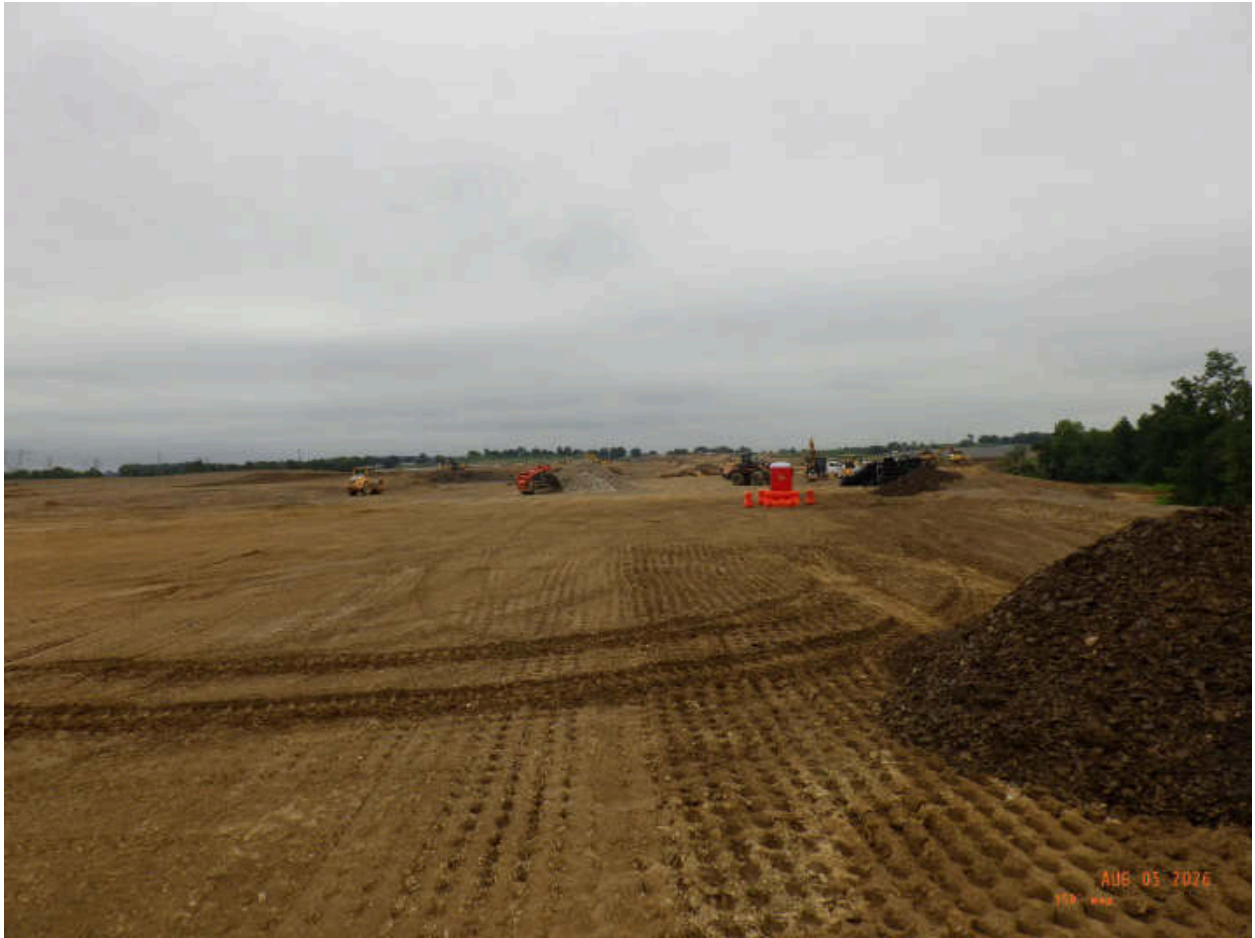
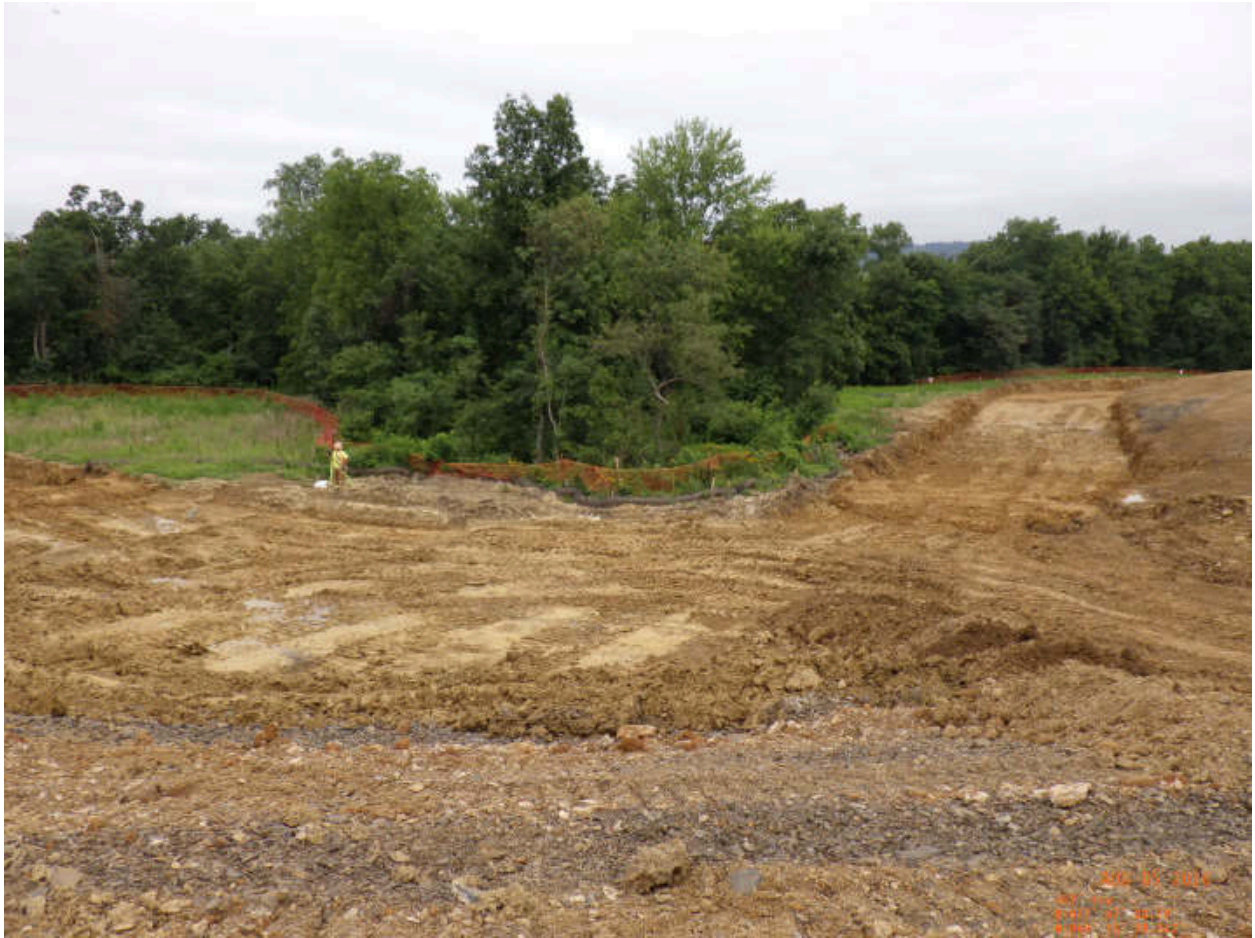
*Photo 53*

15. Perimeter controls on the west side of the site appeared to be functioning as intended based on visual observation. The area appeared to be in preparation for retaining wall construction. The top of slope berm has been installed and appeared to be functioning as designed. The approved construction sequence (Step 23) references Sediment Basin R1 construction prior to retaining Wall 3 for Campus 1. Photos 53–57 & 59.

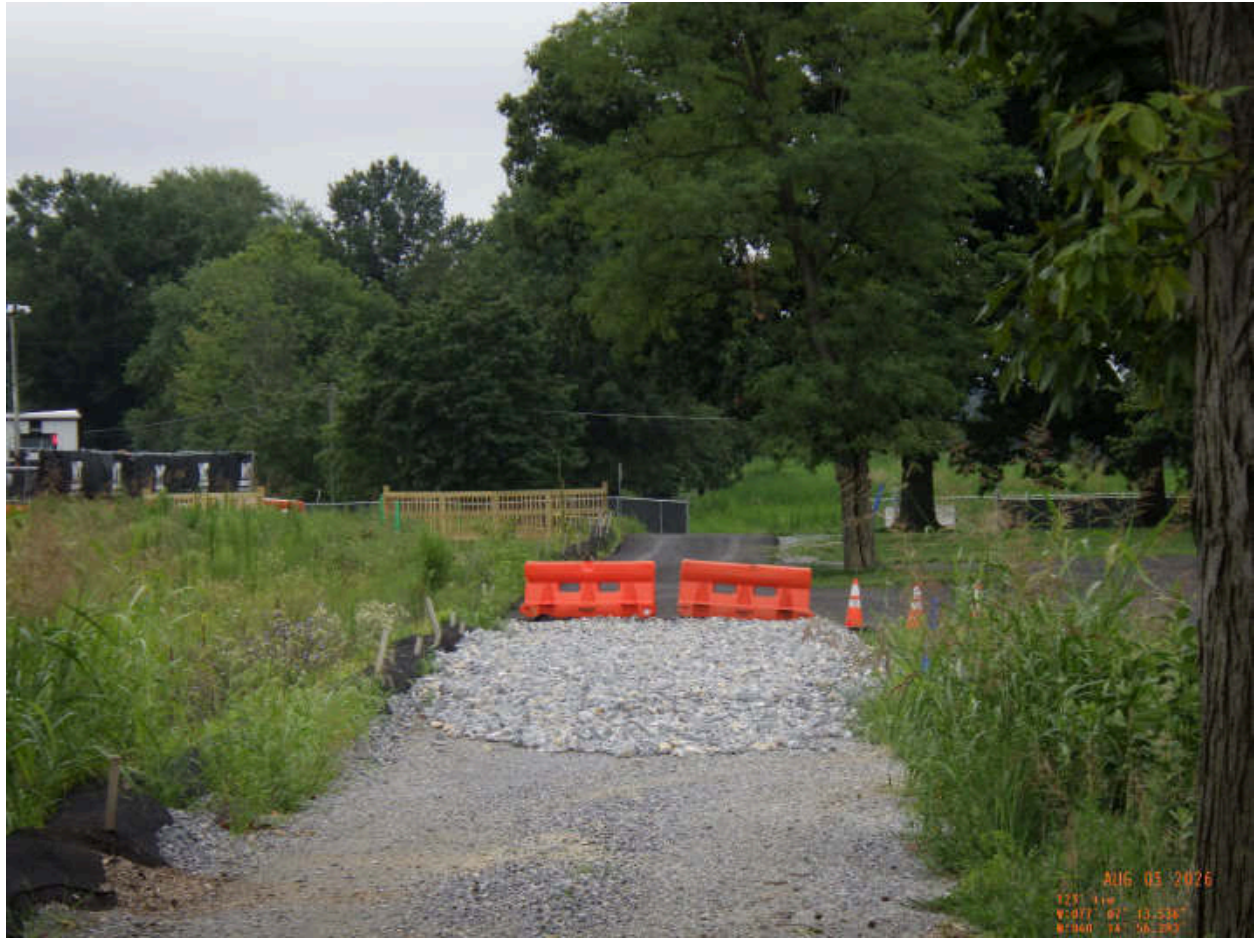
Photo 67

16. Rock Construction Entrance #4 (referenced in previous inspection report as RCE #2) has been installed and was observed to be barricaded as recommended within the inspection report dated 6/17/2026. Photo 67.
